Chesapeake Operating, Inc.
Delmar Light 3H

FORMATION IMAGE INTERPRETATION REPORT

Chesapeake Operating, Inc.
Well: Delmar Light 3H
Field: N/A
Upshur County, West Virginia
API: 47-097-036602

Structural Interpretation of the Delmar Light 3H

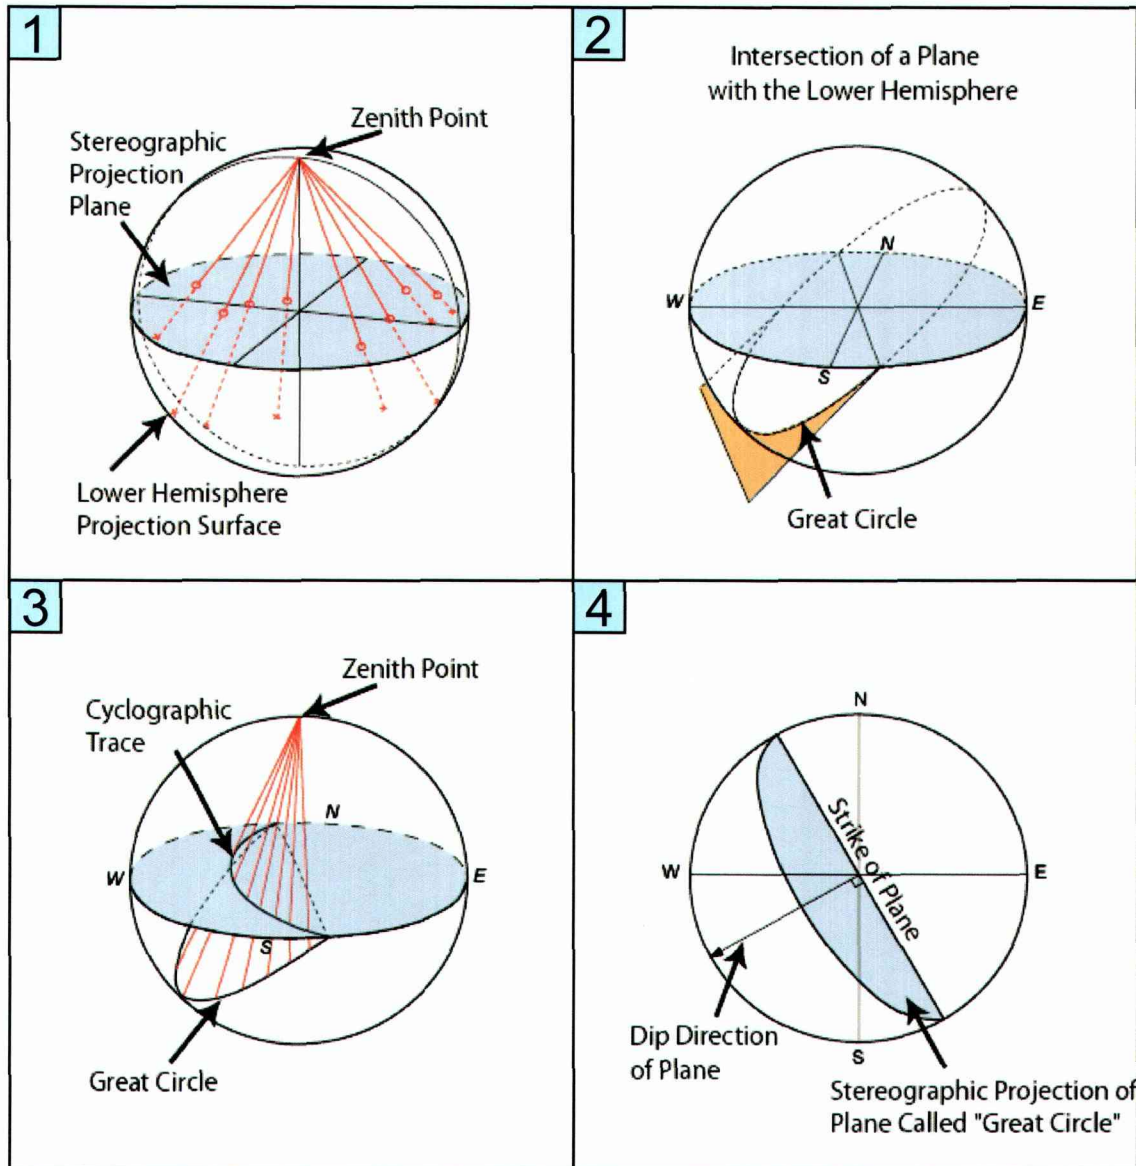
Stereographic Projection of Planes

An invaluable tool for the interpretation of structure and fracture system is the lower hemisphere pole projection. The classification of fractures as open or closed would not be very helpful if the origin and relationship of fractures to each other is not fully understood. The lower hemisphere pole projection assists in achieving that goal.

- 1- The projection of a point on the lower hemisphere lies along a line drawn from the point to the zenith.
- 2- Plane intersecting the lower hemisphere describes a great circle.
- 3- Lines drawn from the great circle to the zenith point intersect the equatorial projection plane describing a circular arc (the cyclographic trace).
- 4- The completed stereogram of a dipping plane.

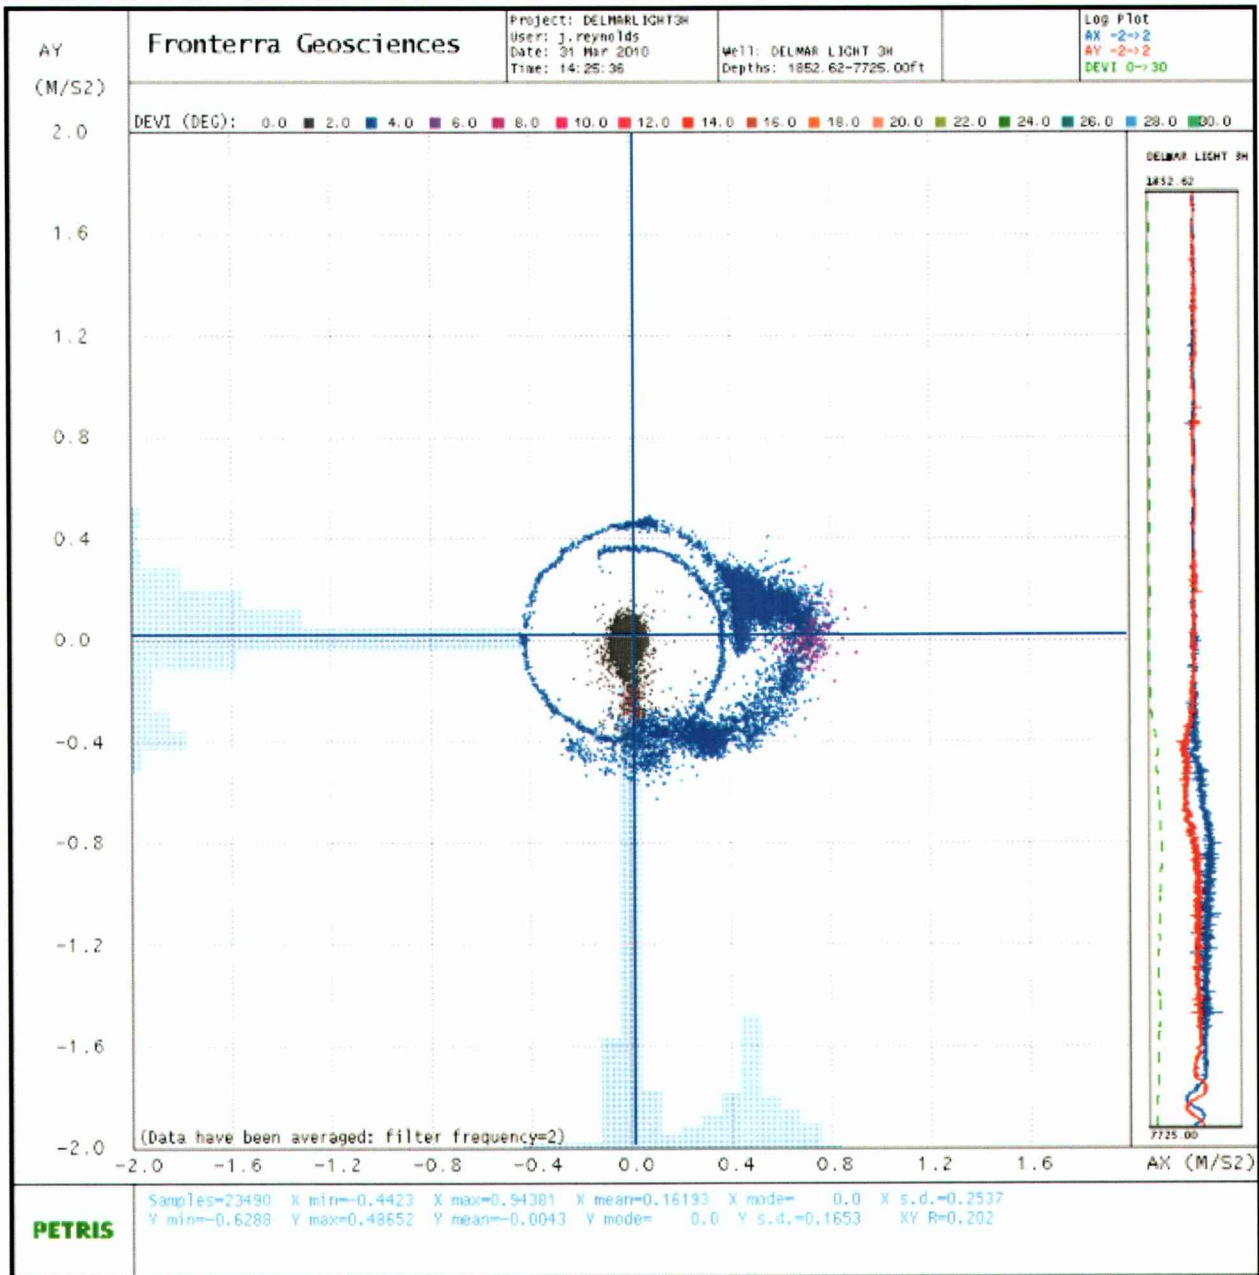
Formation Image Interpretation - Accelerometer Cross Plot -

The cross plot above displays the X- and Y-axis accelerometers from the FMI data showing a circular distribution of values centered over 0, 0. In a wellbore of constant deviation, Accelerometers will plot as a circle with center of (0,0), providing the tool rotates a complete circle. The radius of the circle is affected by borehole deviation. The plot suggests good calibration and operation of the accelerometers and gives us confidence in the accuracy of pad 1 azimuth (P1AZ) and hole azimuth (HAZI). The deviation of this wellbore is below 4 degrees throughout the logged interval. As such the X and Y accelerometers are functioning outside of their operating range as specified by the service companies. We therefore do not provide any quality control of these curves. The Relative Bearing curve generated from these accelerometers is not used at any point in the image interpretation for this reason and the accuracy of the interpretation is not in any way compromised.

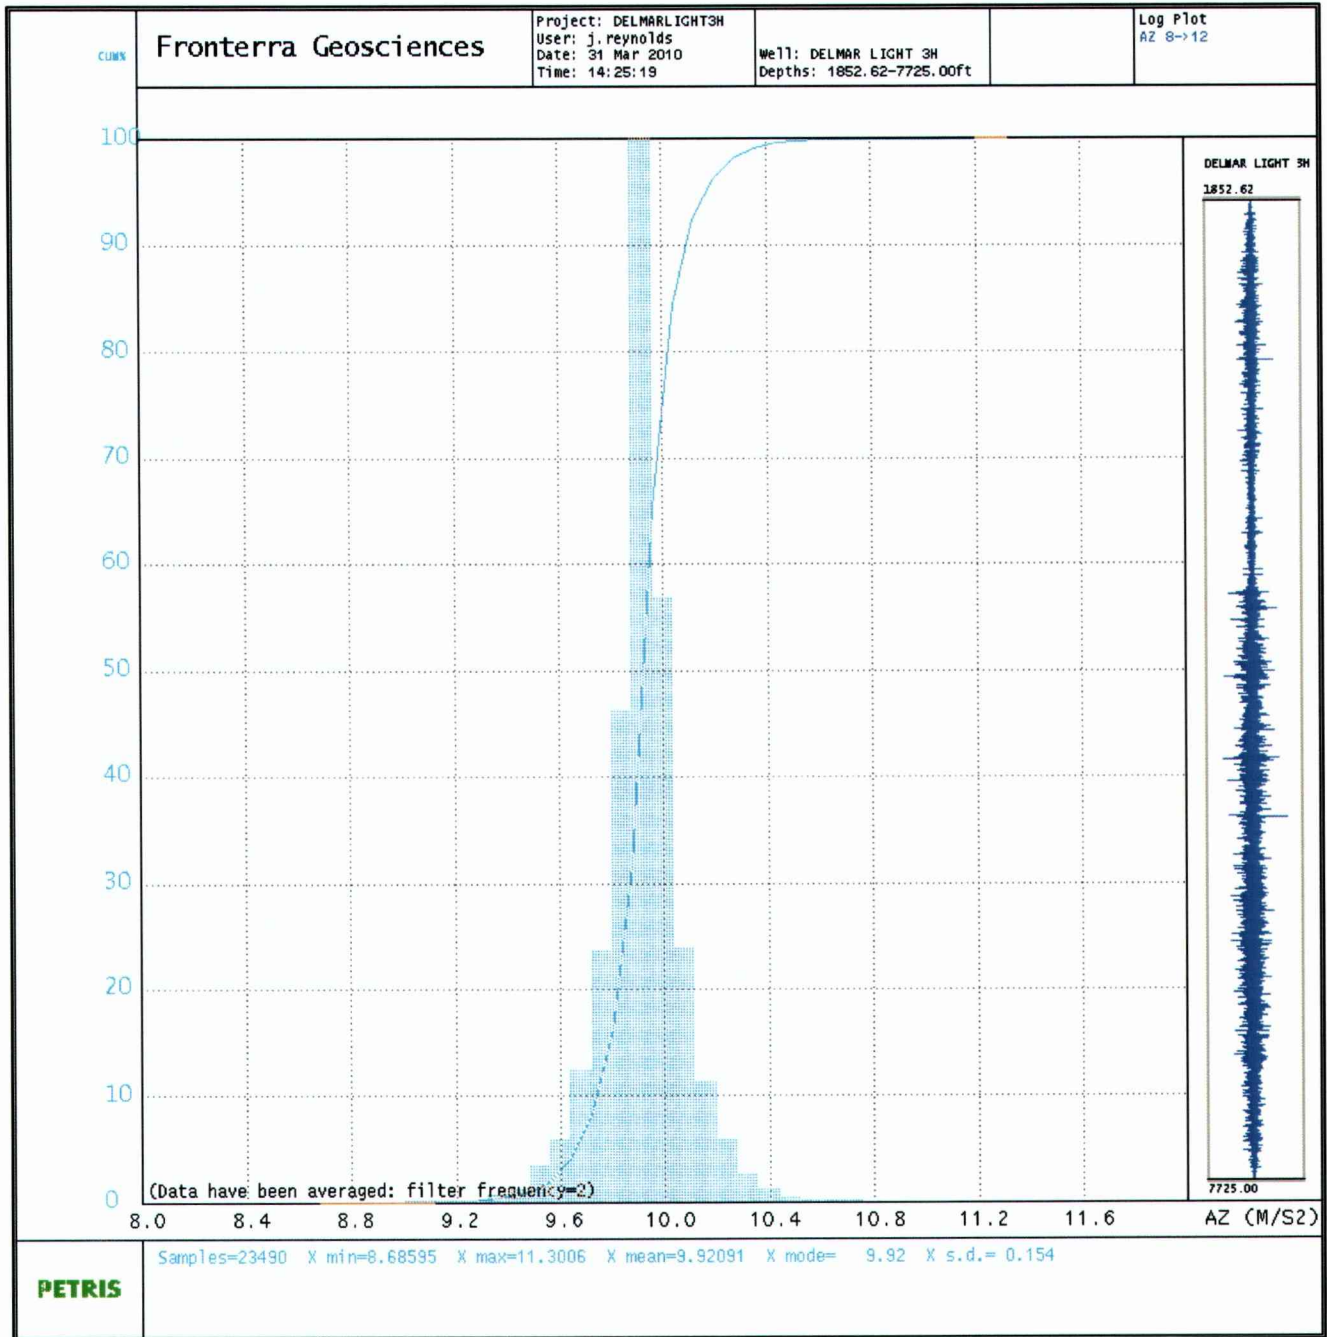
Formation Image Interpretation - Accelerometer Histogram -

The histogram of the Z-axis accelerometer from the FMI data confirmed the correct functioning of the instrument's accelerometer. The distribution of values indicates that the image tool encountered minor tool "stick and pull" throughout the processed interval.

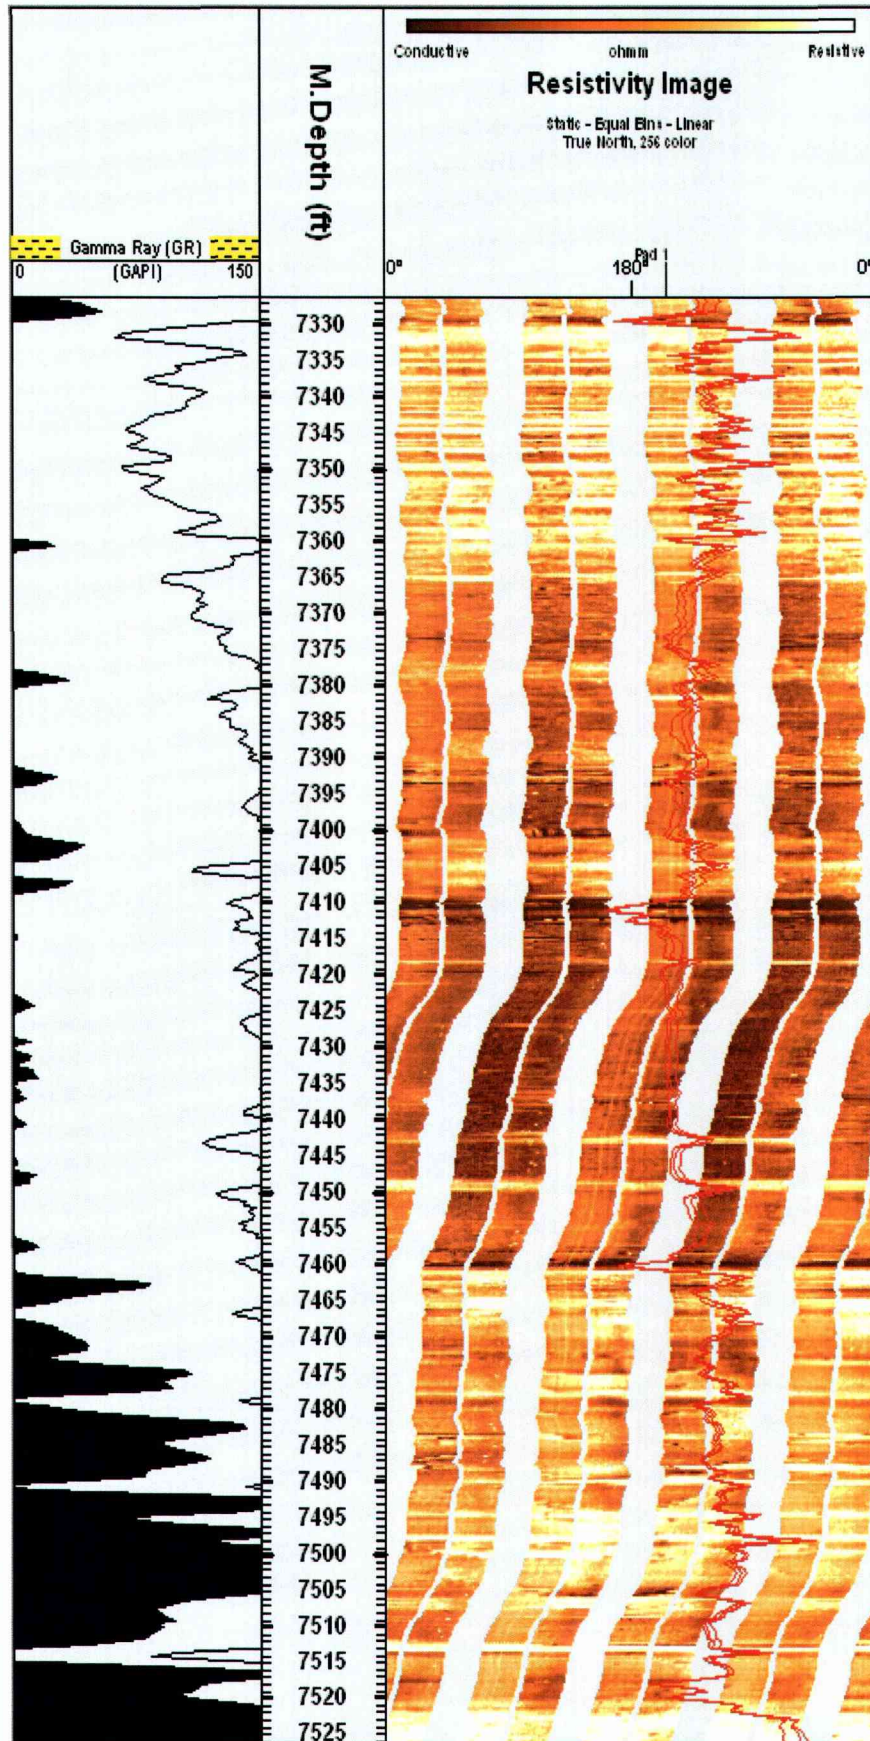
The interval from 7,325 ft to 7,535 ft is presented to the left to verify that the image is on depth with the open hole log data. The resistivity curves (RLA2, RLA3, RLA4, and RLA5) were overlaid onto the resistivity image to verify that the image is on depth with the open hole logs. Zones of high resistivity on the image match with high resistivity intervals on the open hole logs, and low resistivity intervals on the image correspond with low resistivity open hole response. As additional verification of depth matching, the Gamma Ray curve from the open hole logs (GR) was plotted to the left of the formation image. No depth shifting was required.

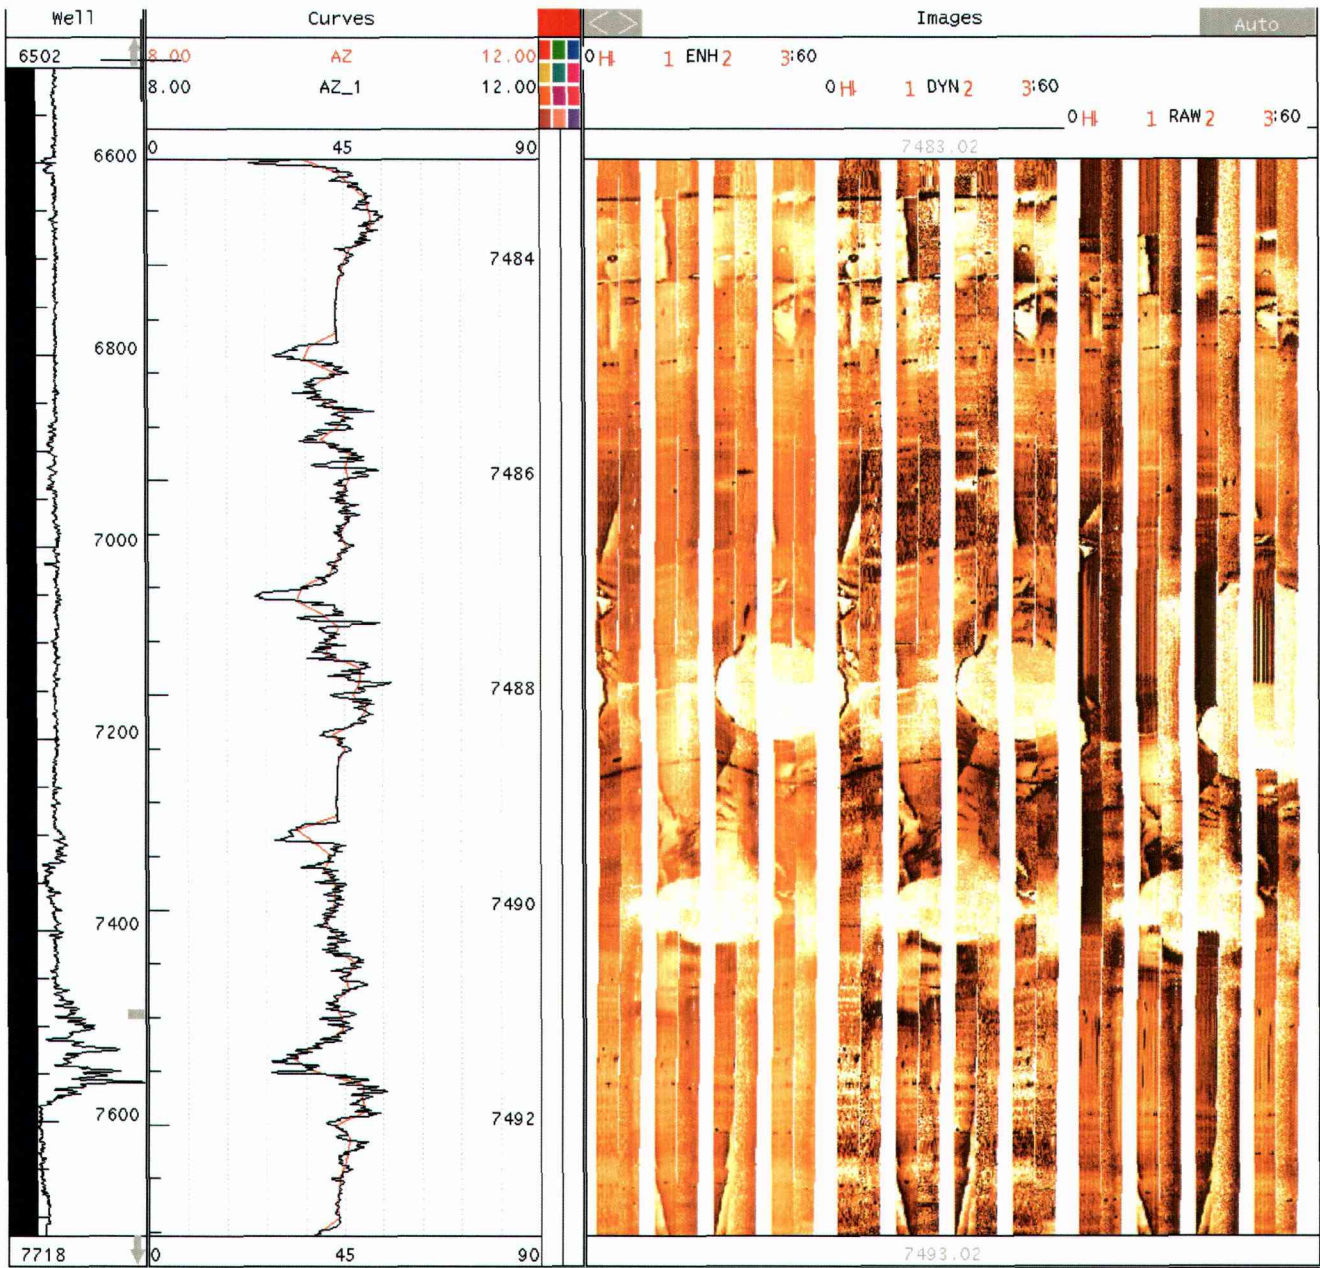
The interval from 7,483 to 7,493 ft is presented to show a before and after of the speed correction of an image. The log track on the left displays the high sample rate and low sample rate Z axis Accelerometer curves. The images displayed are the static speed corrected, dynamic speed corrected and raw non-speed corrected. The wide distributions on the Z-axis Accelerometer indicate stick and pull and can be confirmed on the raw image.

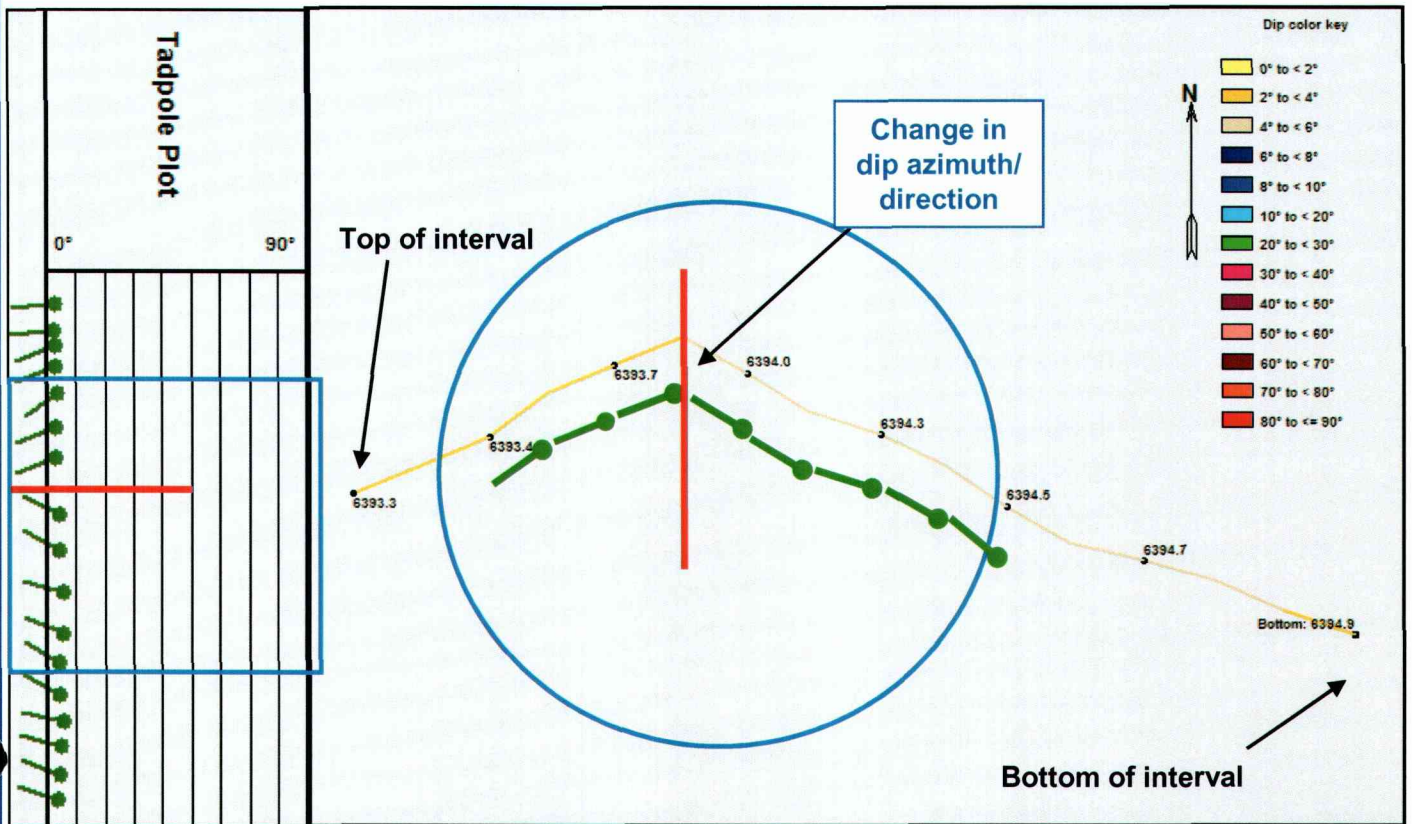
Example of a Schematic Dip Azimuth Walk-Away Diagram

A useful technique in structural and stratigraphic evaluation is the dip azimuth trend analysis. This is accomplished through the creation of a cumulative dip azimuth plot (above and next page). Please note the above example is not taken from the Delmar Light 3H well.

In the above example, tadpoles representing planar bedding surfaces are presented in both the Tadpole Plot (left side, plotted in a depth relationship) and in the walk-away diagram (right side in plan view). Azimuthal vectors are accumulated – end to tip – from the bottom of the well to the top. Detail within the blue circle corresponds to bedding at the depths surrounded by the blue box. A change in bedding dip azimuth is noted by the red bar in both the Tadpole Plot and walk-away diagram. Color coding indicates ranges of dip magnitude as per the legend in the upper right corner.

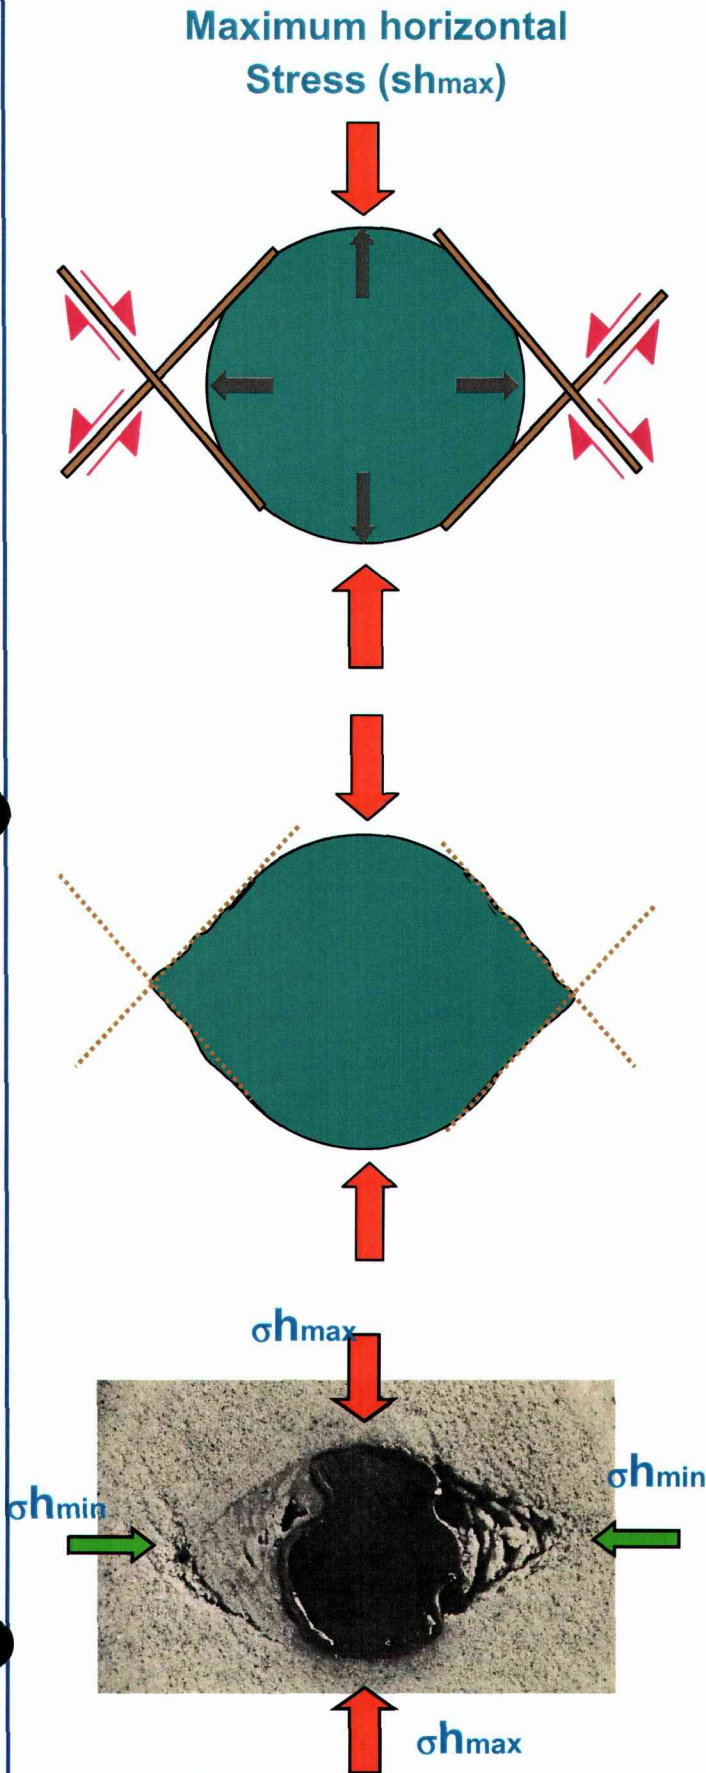
In-situ stress Borehole Breakouts

Above is an image log example of borehole breakouts observed in the undifferentiated formation. The diagrams to the left aid in explaining their formation. These features form as a result of compressive shear failure along the borehole wall. These features form 180 degrees apart from each other and are oriented azimuthally in the *in-situ* minimum horizontal stress orientation. The borehole breakouts observed within the Delmar Light 2H are not as conductive as seen in previous wells and this might be due to the mud type and/or lithology.

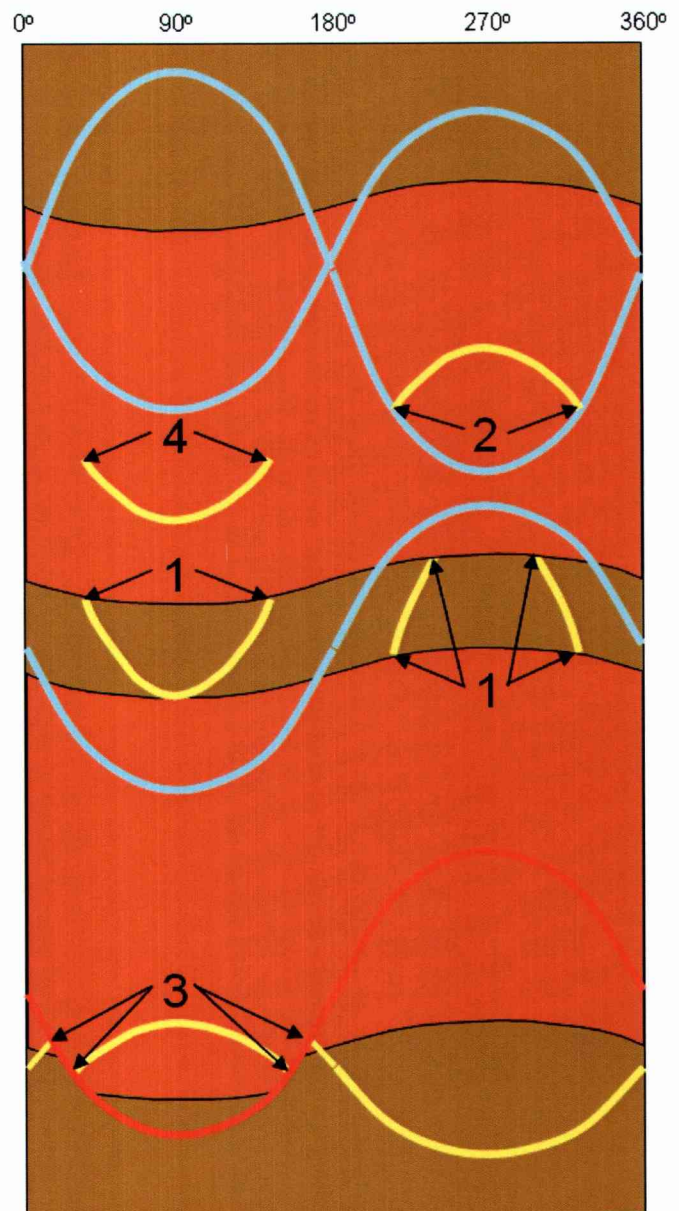
- Fractures that intersect the entire wellbore show a complete sinewave
- Illustrated at right are
 - **Full sinewave** fractures with **no shear**; i.e. no offset of bedding or other fractures (**Pale Blue**)
 - **Full sinewave** fractures with **apparent shear**; i.e. that **offset** bedding and/or pre-existing fractures (**Red**)
- Some fractures however, show only:
 - **Partial sinewaves** (**Yellow**)
- These partial fractures can show a variety of **termination types**
 - **Type 1** terminates against bedding surfaces
 - **Type 2** terminates against other fractures
 - **Type 3** terminates against a shear fracture (i.e. offset by, & therefore predates, the shear fracture)
 - **Type 4** terminates within a particular bed, but not against any obvious or visible surface

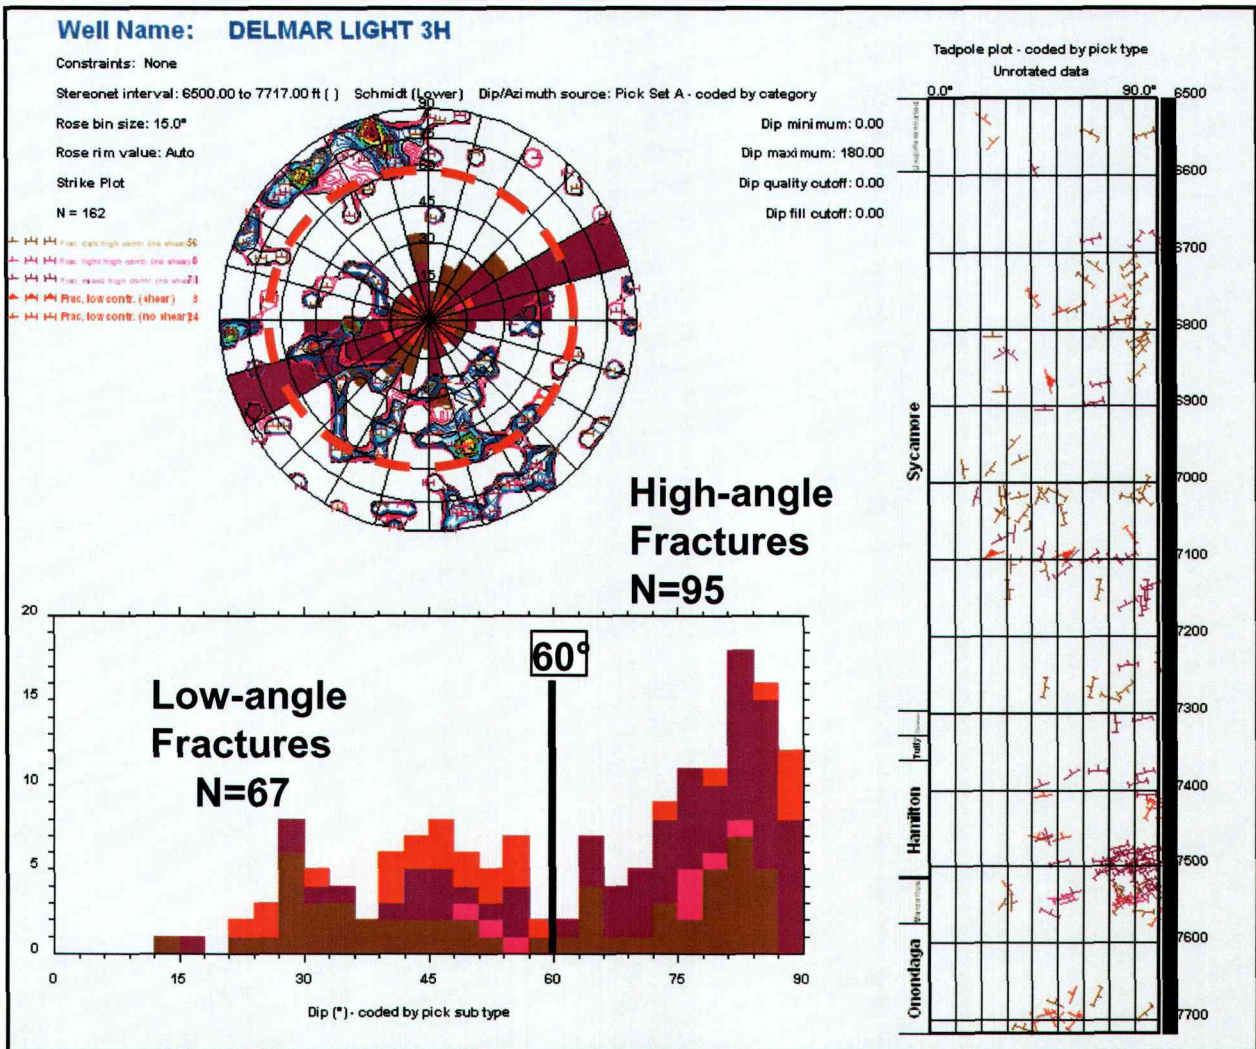
Fracture System Interpretation 6,504 ft to 7,717 ft

A total of 162 natural fractures are identified within the interpreted interval of 6,504 ft – 7,717 ft of the Delmar Light 3H well. Natural fractures are defined by those fractures that are related to the deformation of the rock and include such features as faults, joints, veins, and cracks (Ameen, 2003). All the natural fractures are termed mesofractures, fractures that can be fully characterized using a borehole imaging tool (Ameen et al., 2010). The fractures are plotted on a lower hemisphere contoured Schmidt plot above by fracture type along with the spatial distribution to the right. The observed fracture types include mixed and dark high contrast, light high contrast and low contrast. The fractures are divided into low-angle fractures and high-angle fractures based on a dip magnitude of 60°—i.e., low-angle fractures have a dip magnitude of less than 60° and high-angle fractures have a dip magnitude of 60° or greater. There are 67 low-angle fractures (some low-angle fractures show displacement along the bedding planes) and 95 high-angle fractures that were observed within the interpreted interval—no high-angle fractures showed displacement along the fracture trace. Thus the high-angle fractures are classified as mode 1 fractures—i.e., joints. Both fracture types are further discussed on the following pages.

The dashed red-circle denotes the 60° circle on the Schmidt Plot.

- A total of 162 natural fractures have been identified within the interpreted interval of 6,504ft – 7,717 ft of the Delmar Light 3H. These fractures are divided into high-angle ($\geq 60^\circ$) and low-angle ($< 60^\circ$) fractures. If the high-angle fractures have no observable displacement they are classified as joints—Mode I fractures. There are 95 joints and no high-angle faults/shears observed. There are 67 low-angle fractures, 3 of which show displacement along the fracture trace (shear fractures). The high-angle joints strike **NE-SW** with minor scatter. The low-angle fractures strike **NE-SW** and **NNW-SSE** along with some minor scattering. No low-angle faults were identified within the interpreted interval. The low-angle shear fractures have scatter. The fractures are divided according to formations, along with a brief summary, please see page 54 for the listing.

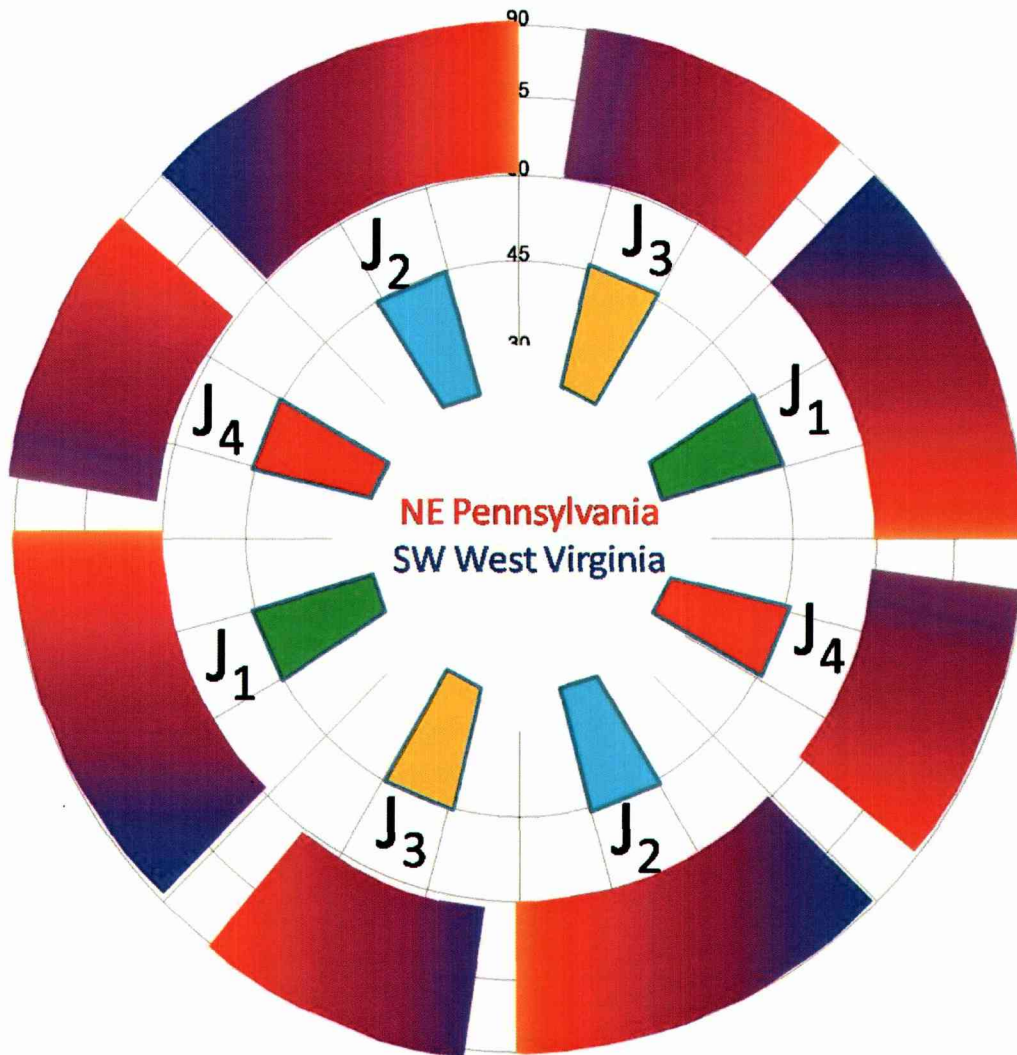
The above diagram displays the strike orientation of 4 common joint sets that have been observed in previously interpreted Chesapeake Marcellus wells. The above diagram was created in order to try and establish consistency among the various reports that are written for the Marcellus Group at Chesapeake. Previous work in the Marcellus Formation has shown there are two well-documented joint sets, these joints are referred to as Joint Sets I and II. Joint Sets III and IV are sets that Fronterra Geosciences have observed in Marcellus formation images and have been named based on order in which the sets were observed in the wells. The naming of the joint sets III and IV does not suggest any structural or tectonic timing. The exact strike is not necessarily consistent from well to well, due to basin dimensions, changes in regional paleo-stress, and possible post-formational rotation due to external forces such as faulting and folding. The colored spectrum (red-purple) indicates documented regional rotation while the colored petals (red, blue, green and orange) indicate colors used by Fronterra Geosciences in the classification of these sets.

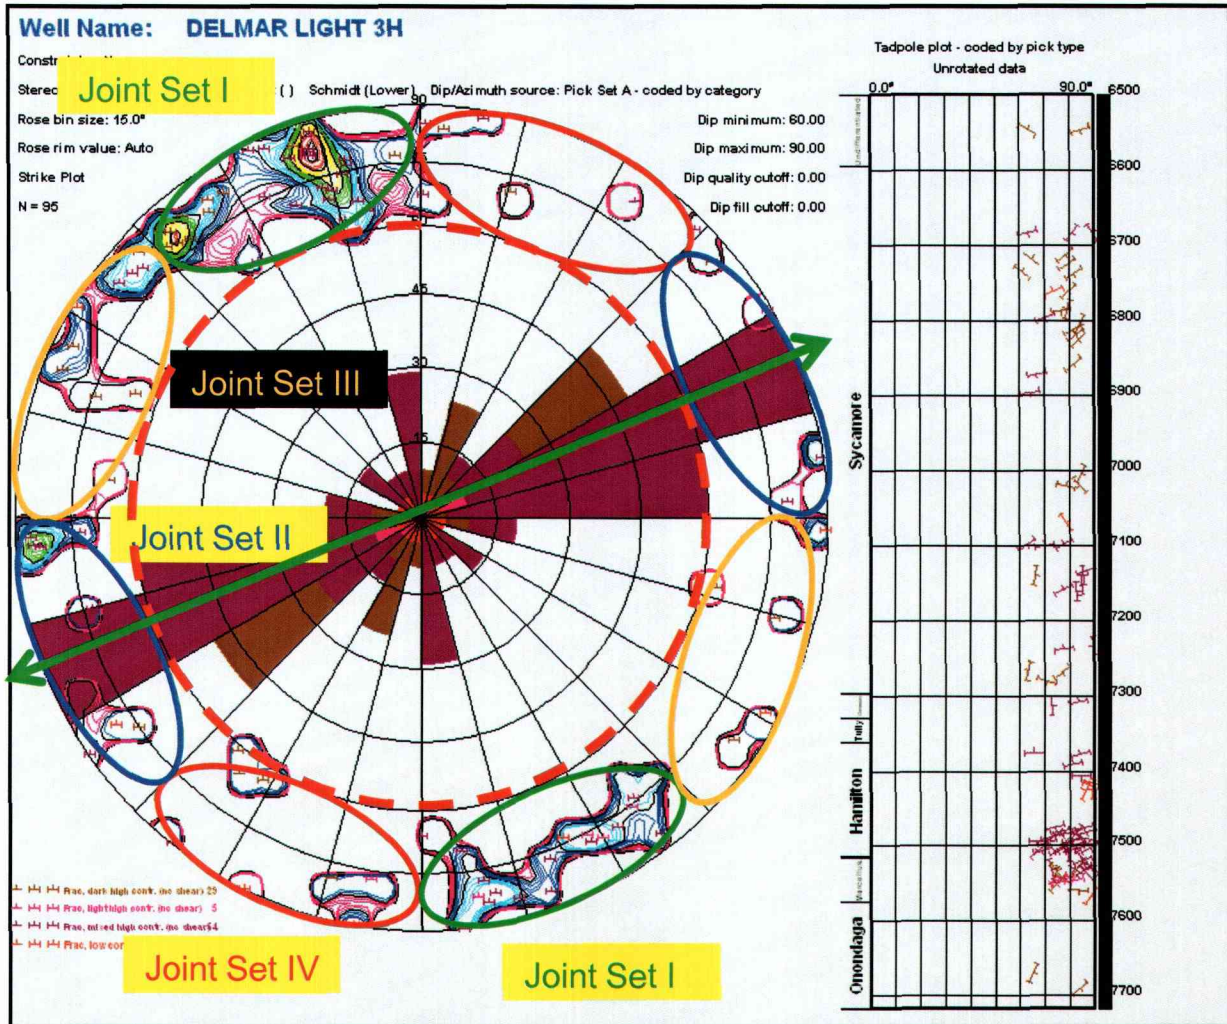
The fracture contour diagram displayed above is used to aid in the identification of natural joint sets (>60° dip magnitude) within the interpreted interval (6,504 ft to 7,717 ft) of the Delmar Light 3H. A total of 95 joints have been identified within the processed interval and consists of light, mixed, and dark high contrast and low contrast joints. No high-angle shear fractures and high-angle faults were observed within the interpreted interval. Most of the joints occur in Joint Set I and the rest of the joint set regions have minor quantities of joints. The attitudes of Joint Set I is listed below:

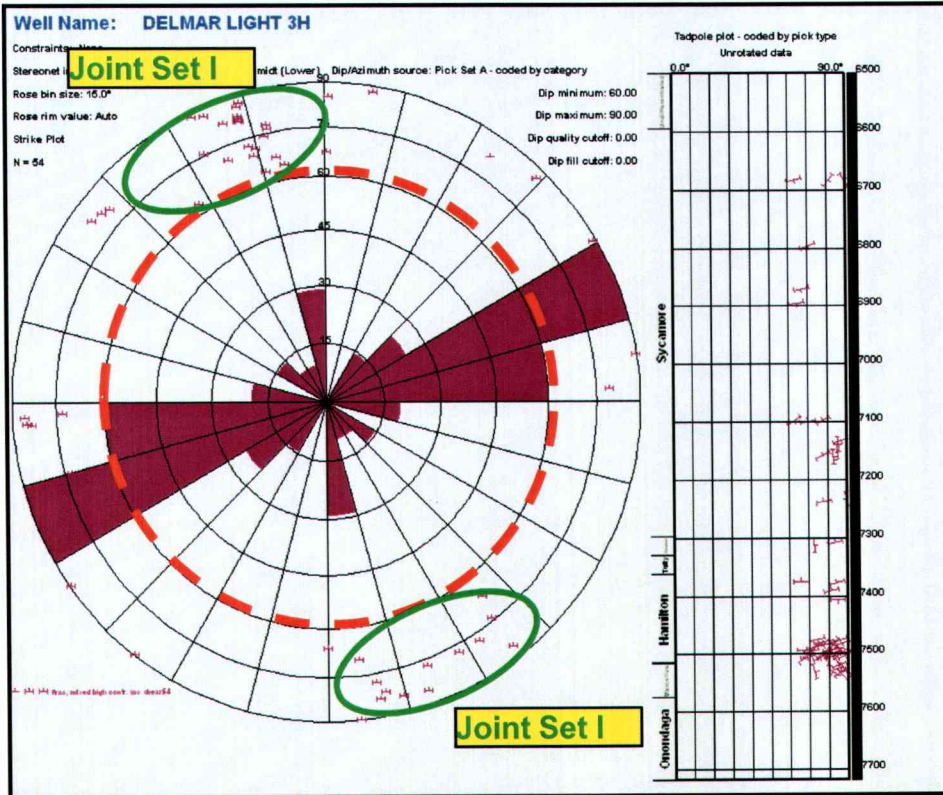
Fifty-four mixed high contrast joints (partially open) have been identified within the interpreted interval. The partially open joints strike **NE-SW** and very minor to the **NNW-SSE** and are mostly related to Joint Set I. The partially open joints are mostly joints that terminate into bedding planes or other fractures. There is only one complete partially open fracture observed.

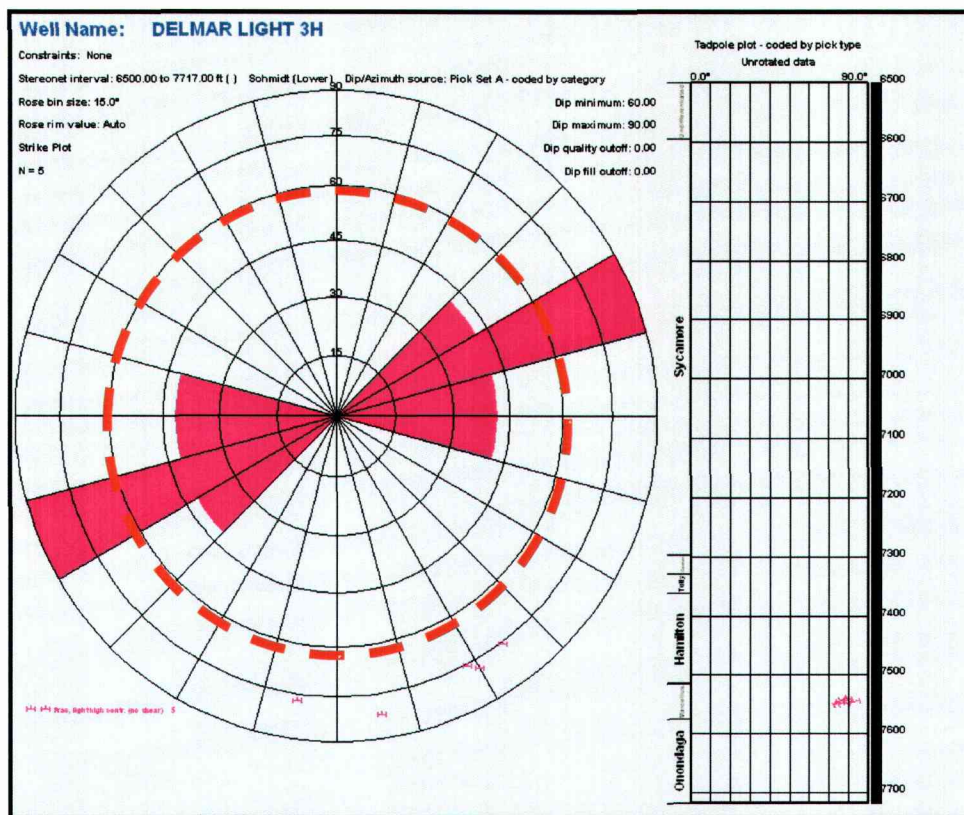
Five light high contrast joints (cemented) are observed within the interpreted interval. These cemented joints strike **NE-SW**. All of the cemented joints terminate into either bedding planes or other fractures.

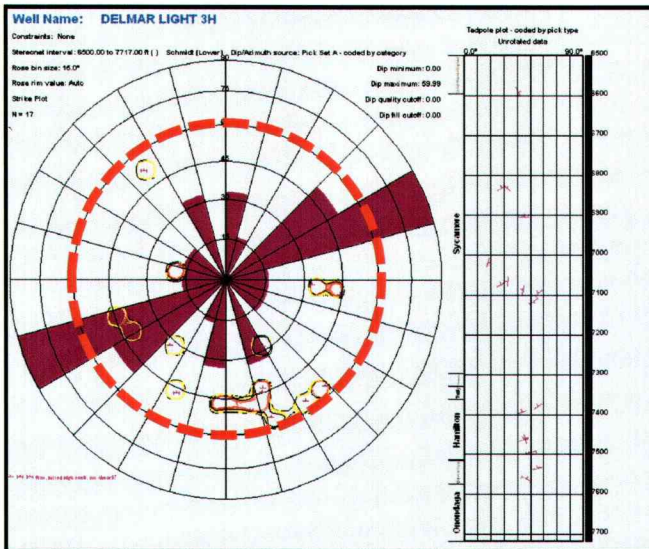
Fracture System Interpretation Low-Angle Fractures with Displacement Vs. No Displacement (6,504 ft to 7,717 ft)

Low-Angle Partially Open Fracture with Shear

Low-Angle Closed fractures with Shear

Low-Angle Partially Open Fracture with No Shear Low-Angle Closed Fractures with No Shear
