**Cambrian No. 1 Project
McCormick
Wayne County, West Virginia
Conventional Core Samples**

Weatherford File No.: HH-77641

**THIN SECTION MACRO PHOTO
SAMPLE DEPTH: 12134.00 FEET
SAMPLE NUMBER: 1 CK-McCormick**

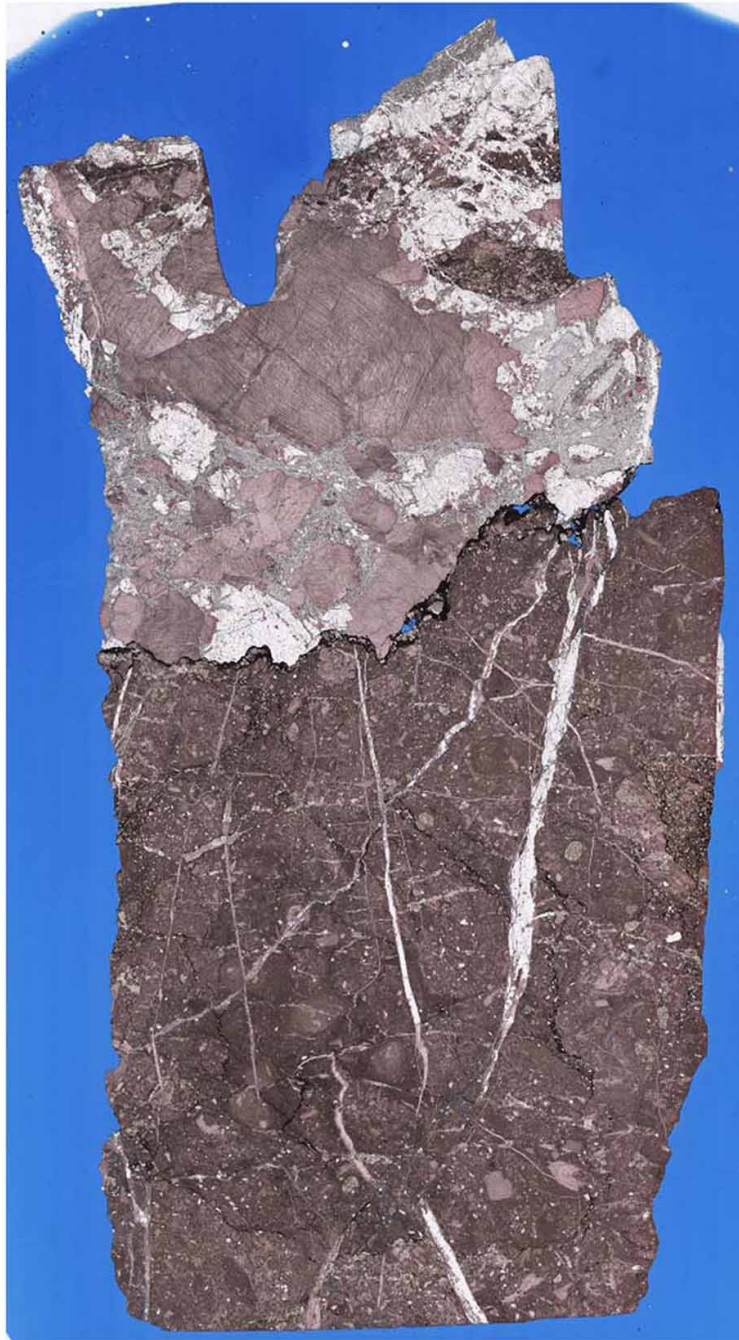
A

This static macro photo was captured from the high resolution thin section mosaic image and documents the entire thin section slide.

Lithology: Fluorite/dolomite/barite-rich limestone

Texture: Chaotic (possible slumping/collapse or fault-shear zone); highly fractured with fractures crisscrossing at multiple angles; organic-rich stylolites and bitumen-filled fractures; a prominent pyritized, horizontal stylolite separates the lower section from the upper section; the lower section consists of highly fractured peloidal, intraclast-rich wackestone to packstone with isolated patches of peloidal grainstone (this lower portion appears to have been under represented in the XRD sampling); the upper section is crystalline and chaotic with numerous cemented fractures containing fluorite, calcite, and barite (this upper section appears to be most represented in the XRD results)

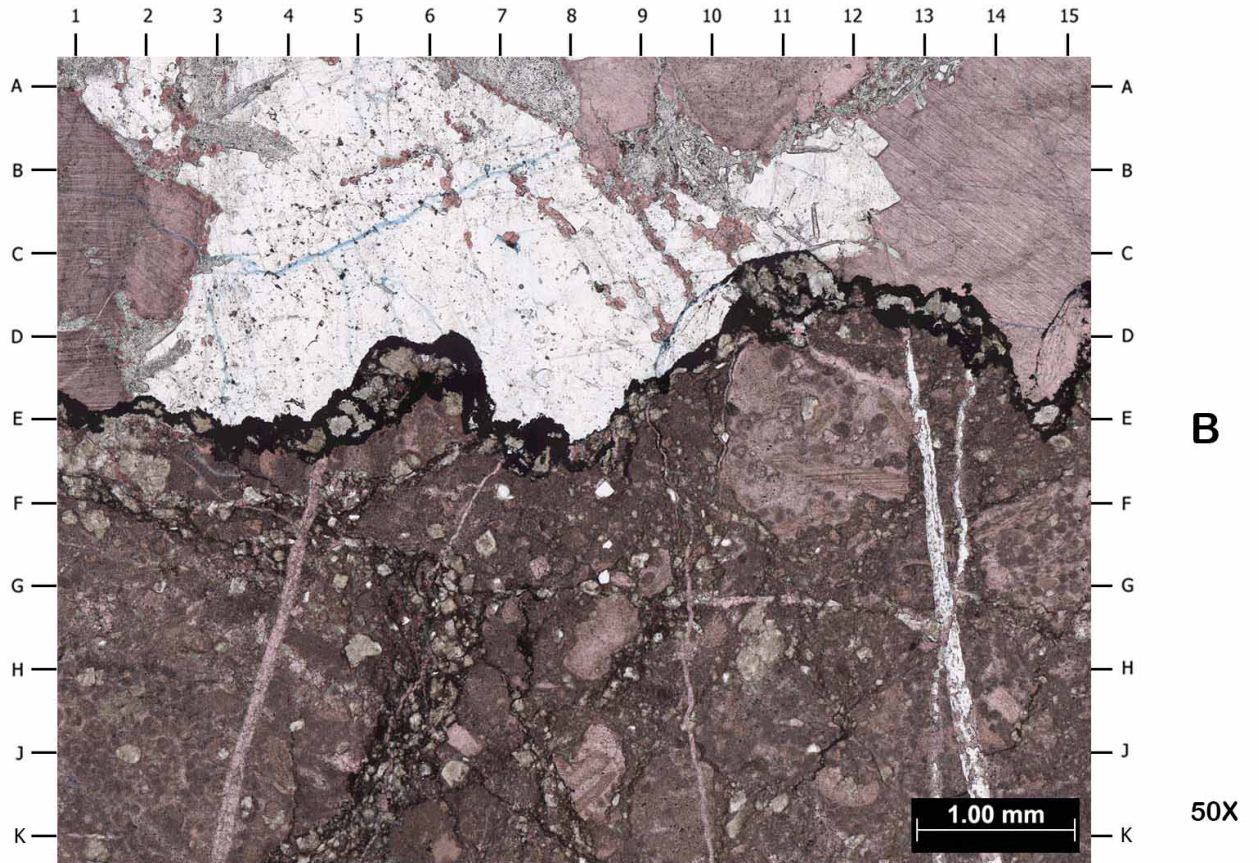
B) This photo documents a pyritized stylolite (E1 to DE15; black) that delineates the two main textures represented in this limestone sample. The upper section (above the largest stylolite) is dominated by large crystals of fluorite (white; CD3-10, BC11.5, A2), calcite (stained red; BC13-15, A10.5, BC1-2.7, AB8.5), and barite (A1, AB3, A7.5, B9.5, A12.7). The lower section is a chaotic mix of intraclasts (FG14-15, EF10-12.5), micritic peloids, and echinoderm fragments (GH8.5) in a partially recrystallized micrite matrix with numerous cemented fractures (DE12.5-J13.9, EF4.5-K3) and microstylolites crisscrossing the sample.

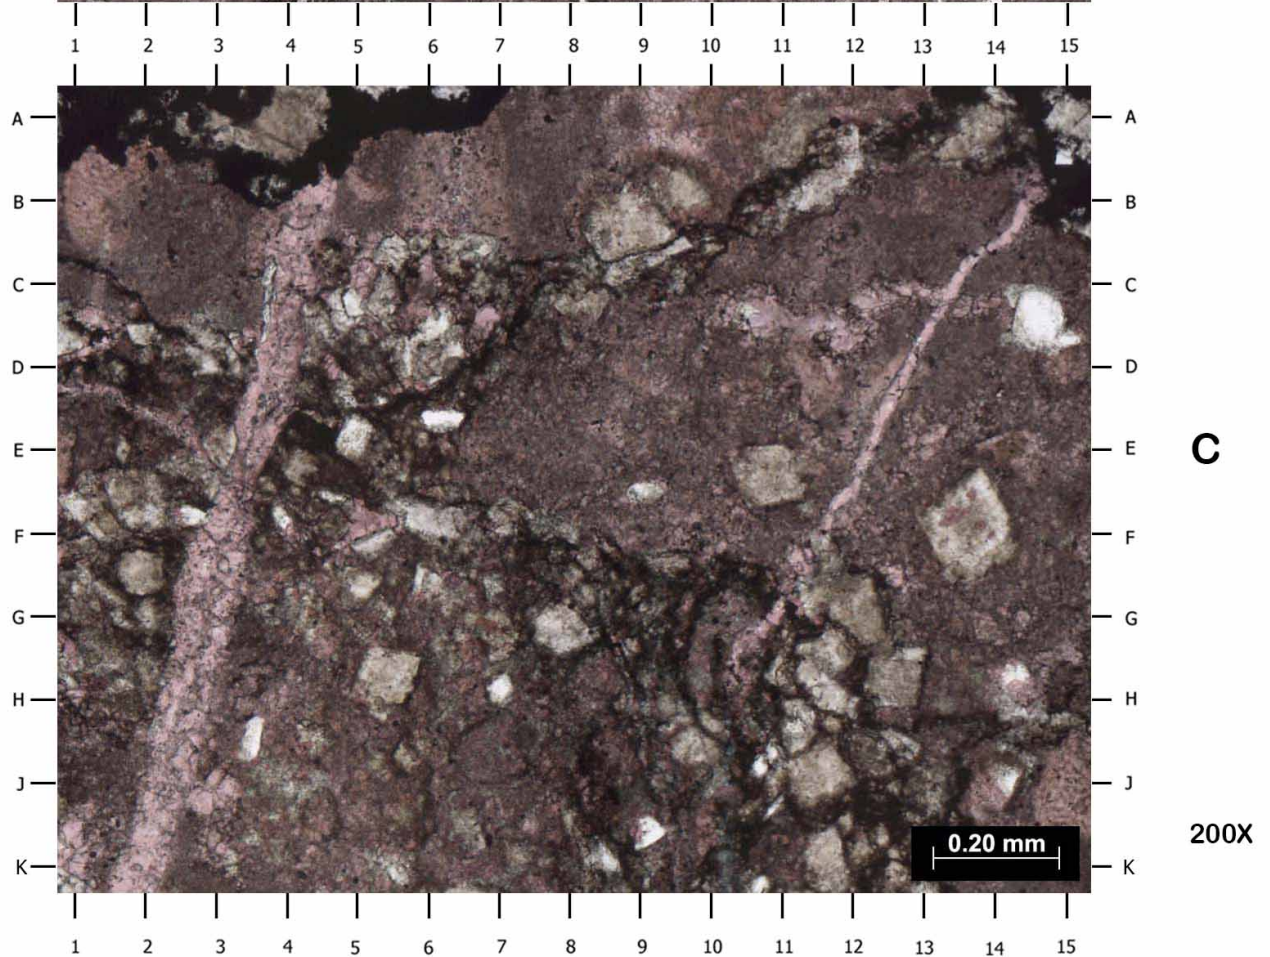
C) This photomicrograph provides a high magnification view of the area centered near FG5 in Photo B. Partially pyritized bituminous organic material (black) occurs concentrated along stylolites (A1-7) and microstylolites (D1-A15, D1-JK12.5). Dolomite crystals precipitate along these stylolites (B9, J11.5, FG2). Calcite-cemented microfractures occur at K2-BC4 and GH10.5-BC14.3.

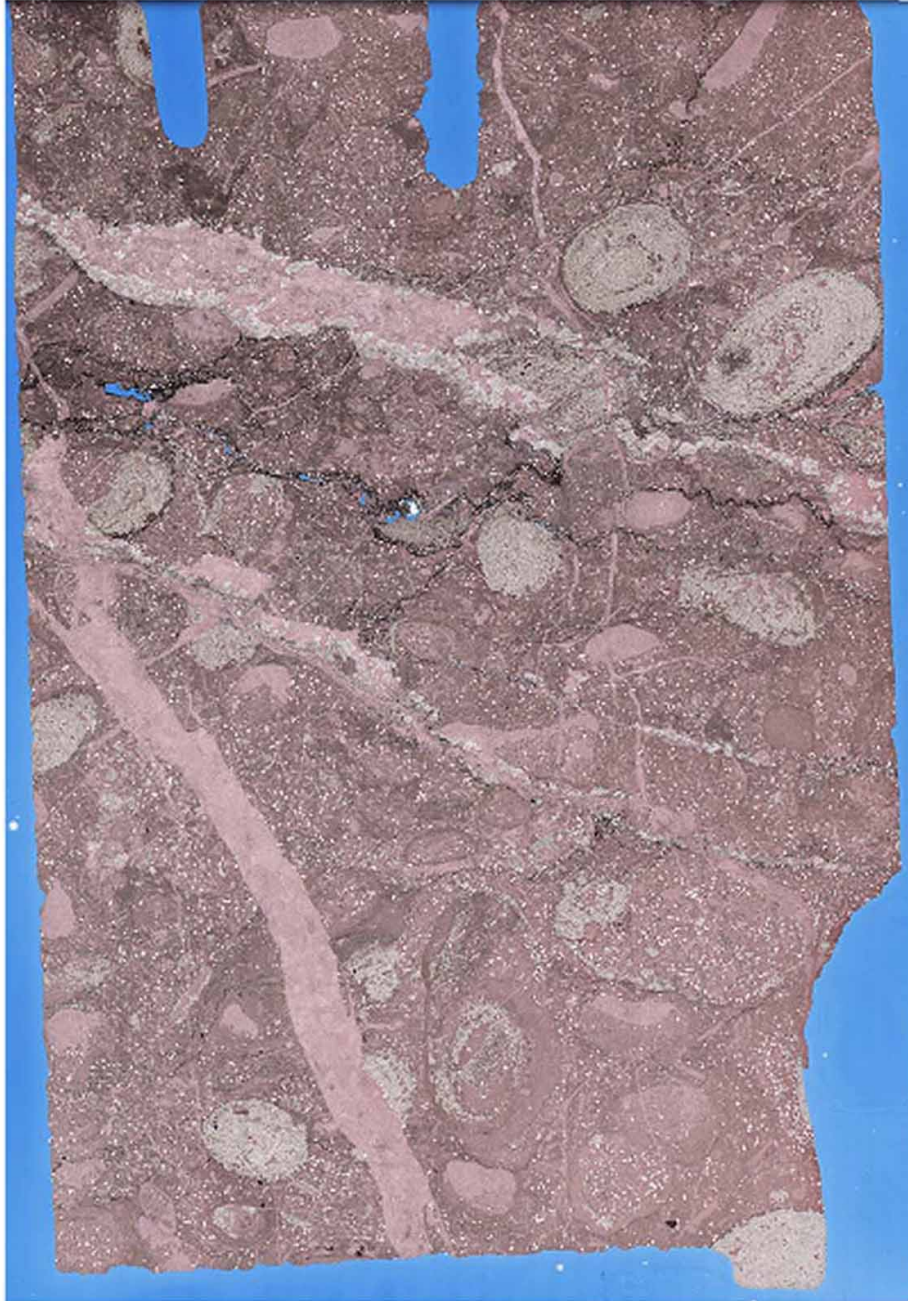
A

This static macro photo was captured from the high resolution thin section mosaic image and documents the entire thin section slide.

Lithology: Slightly silty/sandy, slightly dolomitic limestone

Texture: Massive, pisoidal, intraclast-rich, partially recrystallized wackestone to packstone with rare localized patches of grainstone; large calcite-cemented fractures; organic-rich stylolites and microstylolites

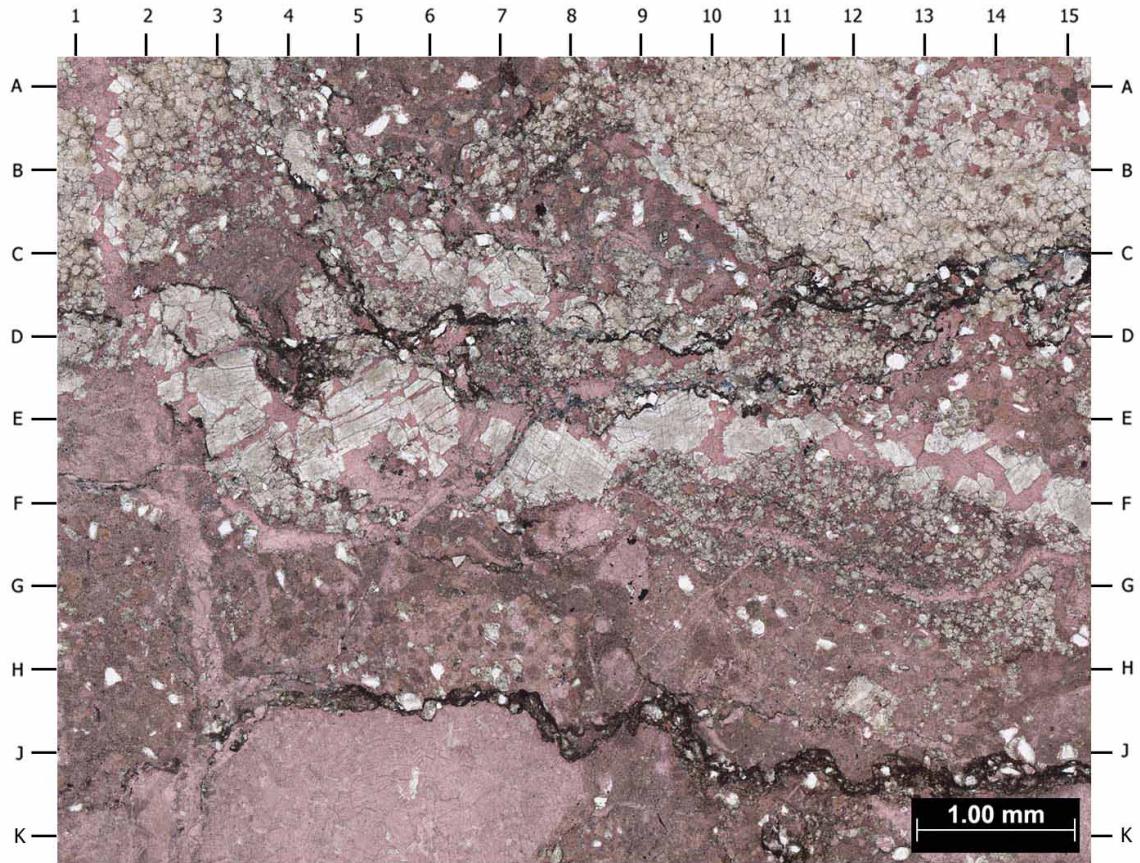
B

- B) This slightly silty/sandy, slightly dolomitic limestone contains large intraclasts (JK2-8, H6-8, H9-HJ14); partially dolomitized pisoids (AB9-15; vague concentric rings are visible in macro photo A); fractures (A1-H3, E1-F15) cemented by dolomite (E3, E5.5, EF8, F15) and sparry calcite (stained red); and organic-rich microstylolites (HJ4-JK15, CD5.5-CD13.5). The matrix between grains/allochems is predominantly partially recrystallized micrite (C3.5, JK9). The intraclast at H6-8 exhibits a peloidal grainstone texture.

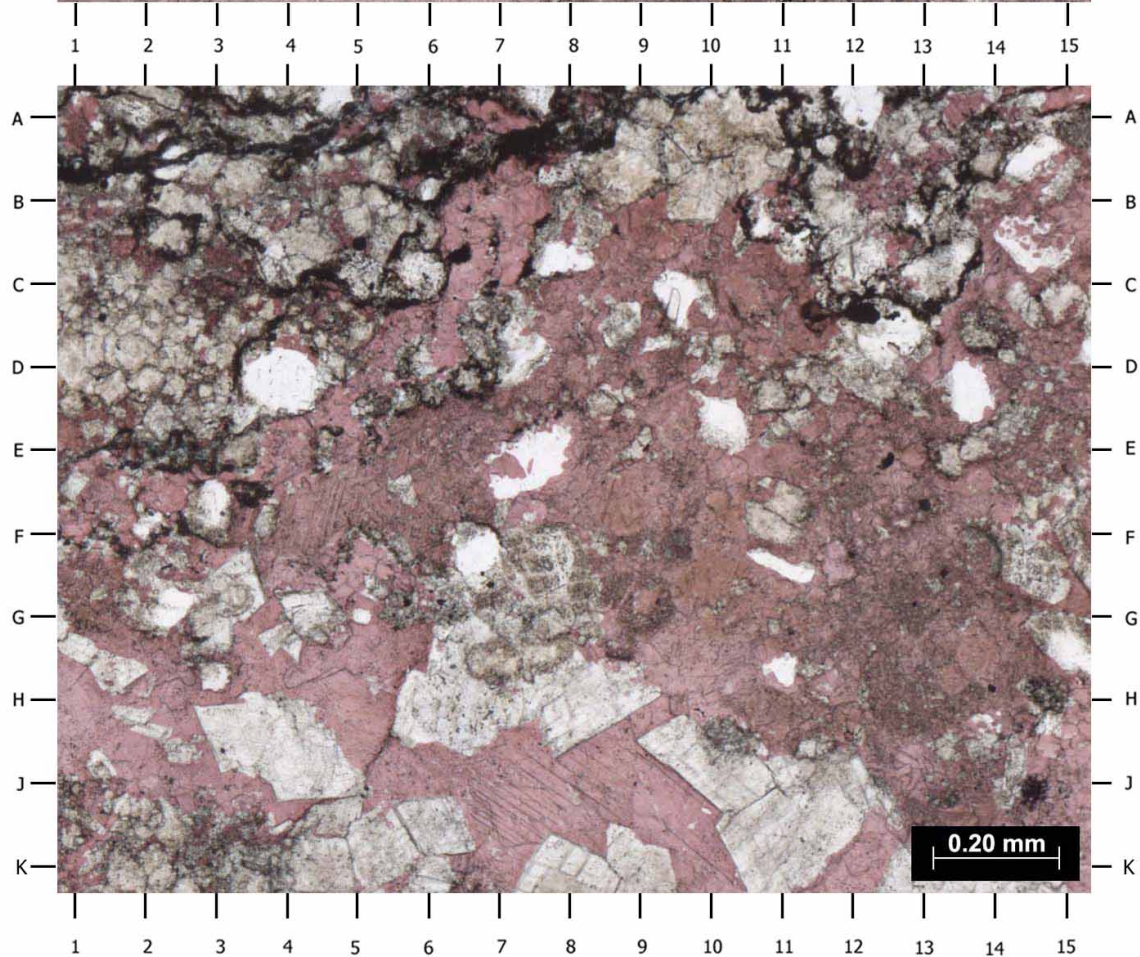
C

- C) This photomicrograph provides a high magnification view of the area centered near DE13.5 in Photo B and documents a small area between a microstylolite (AB1-12) and a cemented fracture (GJ1-K12.5). The fracture is predominantly cemented by sparry calcite (J8, H1, H5) with lesser rhombic dolomite crystals also filling the fracture (HJ4, JK5.5, K8, J11). The microstylolite contains partially pyritized bitumen (black, AB1-2, A11) with additional dolomite (AB10, B3, AB3.5) replacement of the matrix occurring along the stylolite's margins. Visible grains/allochems include quartz grains (DE13.5, DE10, C9.5), feldspar grains (DE4, FG7.8), and vague partially recrystallized peloids (G9, H13). Sparry calcite cement (BC9, EF13.5, EF8.5) occludes the interparticle spaces within this localized area, while in other areas outside this view, the matrix is dominantly micritic.

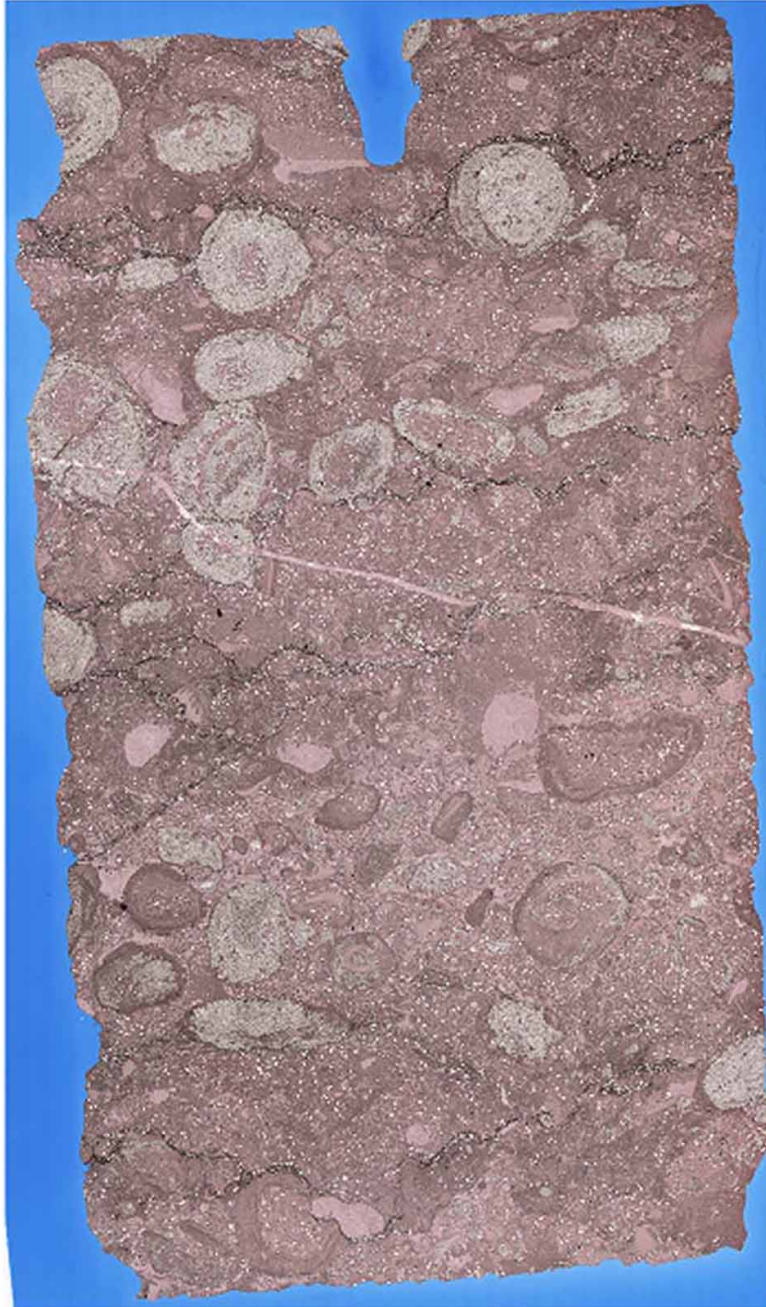
A

This static macro photo was captured from the high resolution thin section mosaic image and documents the entire thin section slide.

Lithology: Slightly silty/sandy, dolomitic limestone

Texture: Massive, pisoidal, mostly partially recrystallized packstone to wackestone with localized patches of peloidal grainstone; calcite-cemented fractures; organic-rich stylolites and microstylolites

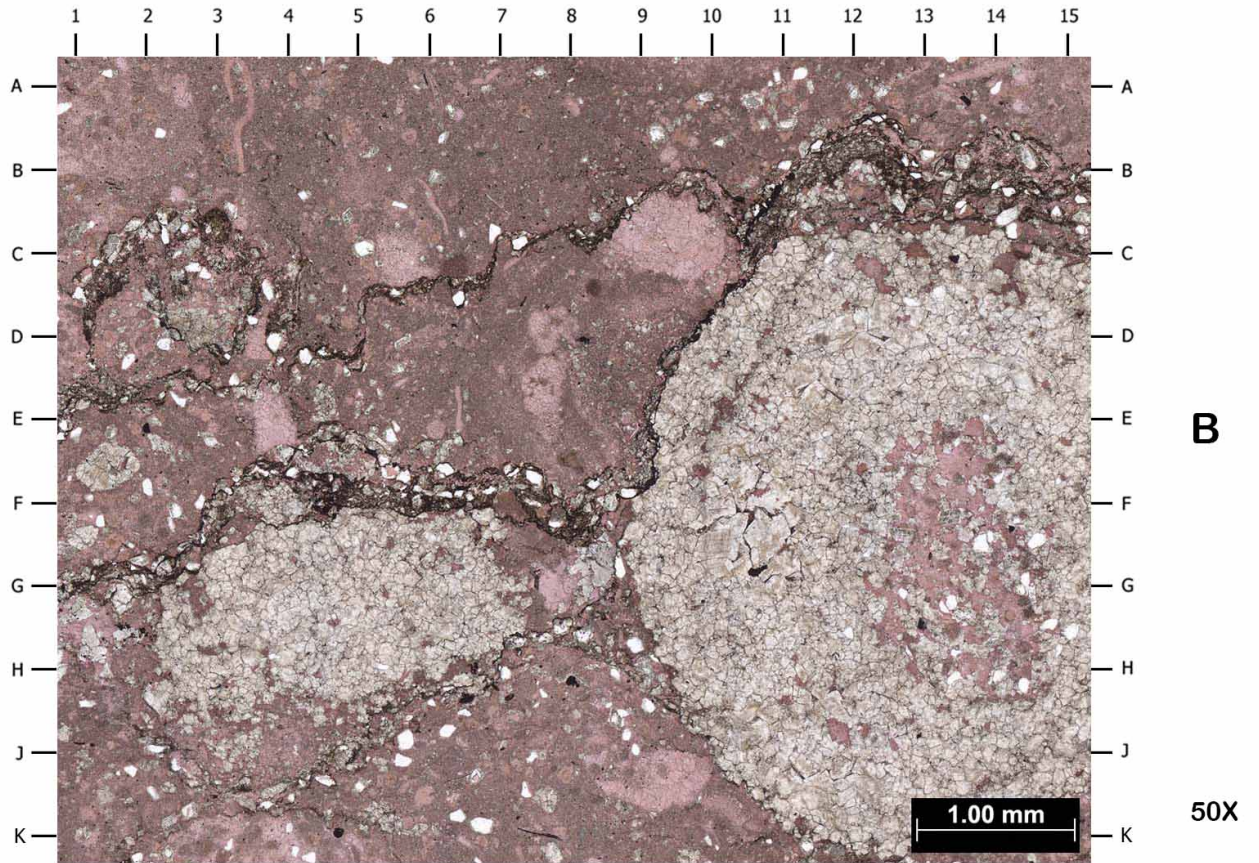
- B) A dolomitized pisoidal grain (CK9.5-15) and organic-rich microstylolites (G1-F8.5, E1-B15) are documented within a slightly silty/sandy, dolomitic, partially recrystallized packstone to wackestone. Minor zones outside of this view exhibit peloidal grainstone texture. Other grains/allochems pictured include dolomitized (GH2.3-GH7) and calcareous intraclasts (BC9.5, JK9.5, D2, K2-4), quartz/feldspar grains (white; C5, JK6.8, J5.6), micritic peloids (A11, AB11.3), and trilobite fragments (AB3.2).

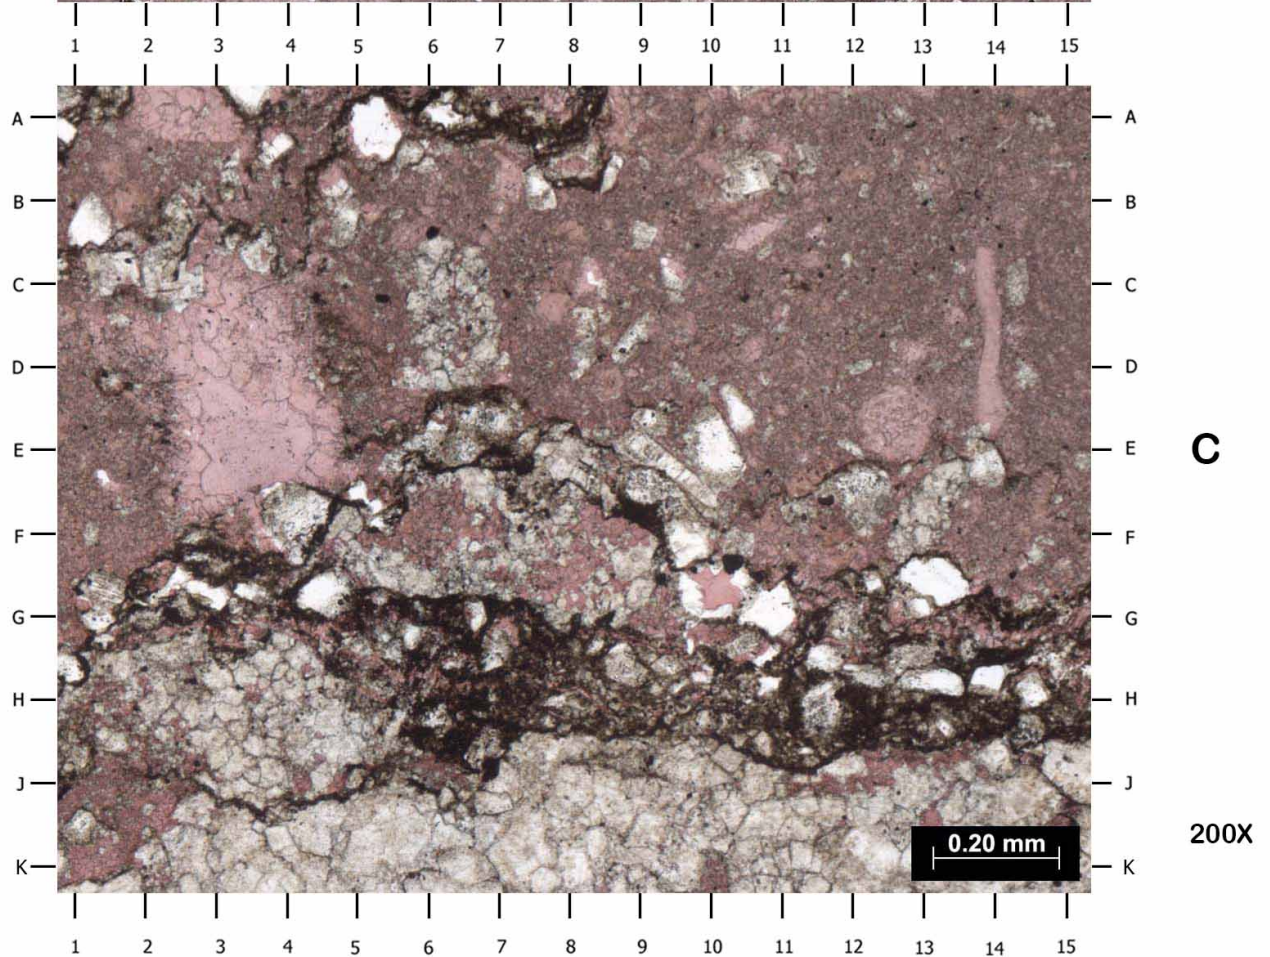
- C) This photomicrograph provides a high magnification view of the area centered near EF5.5 in Photo B. Partially recrystallized micrite matrix (AB14, C12.5, DE1) supports undifferentiated, recrystallized, calcareous allochems (DE12.5, CD14, A2.5, BC10.5, DE3), quartz grains (FG13, AB5.2, G11), and feldspar grains (E9, E13.8). Common to abundant dolomite occurs as replacement of grains/allochems (K2-JK15, HJ2-5, CD6.5, EF13, EF12, C14.3, CD9) and replaces the matrix along organic-rich microstylolites (C2, AB5.9, EF6-8, EF9, GH12.9, H8-10.5).

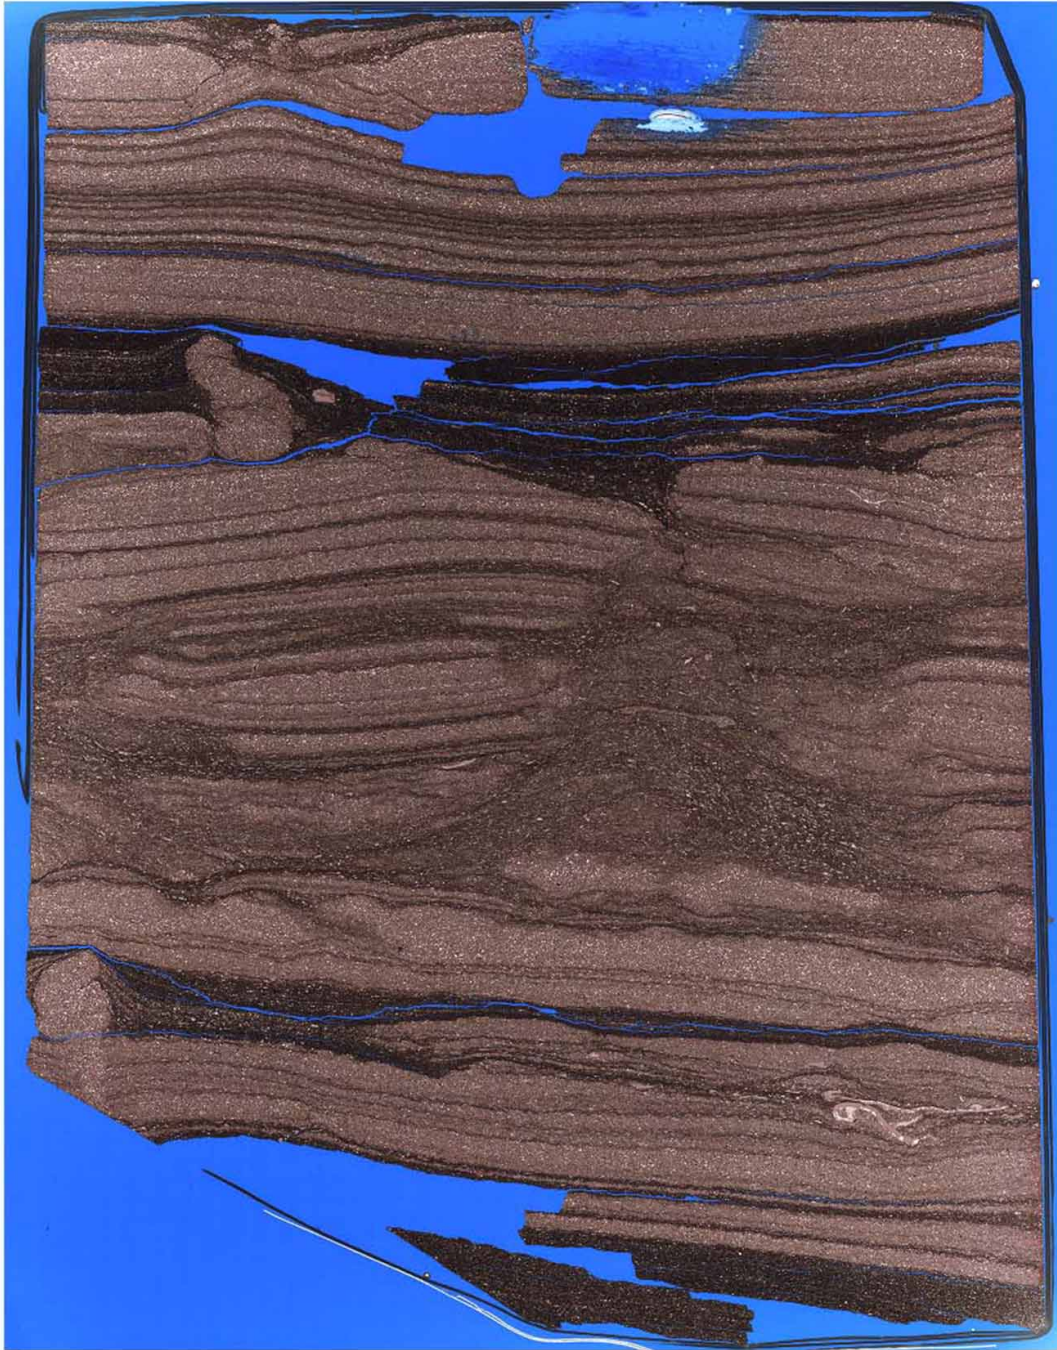
A

This static macro photo was captured from the high resolution thin section mosaic image and documents the entire thin section slide.

Lithology: Limestone

Texture: Laminated; burrowed; thin carbonaceous/clay-rich laminations alternating with peloidal grainstone layers; wackestone/mudstone along thin laminations and within burrowed areas; rare thick carbonaceous/clay-rich laminations (or thin carbonaceous mudstone beds); trace bitumen-filled microfractures

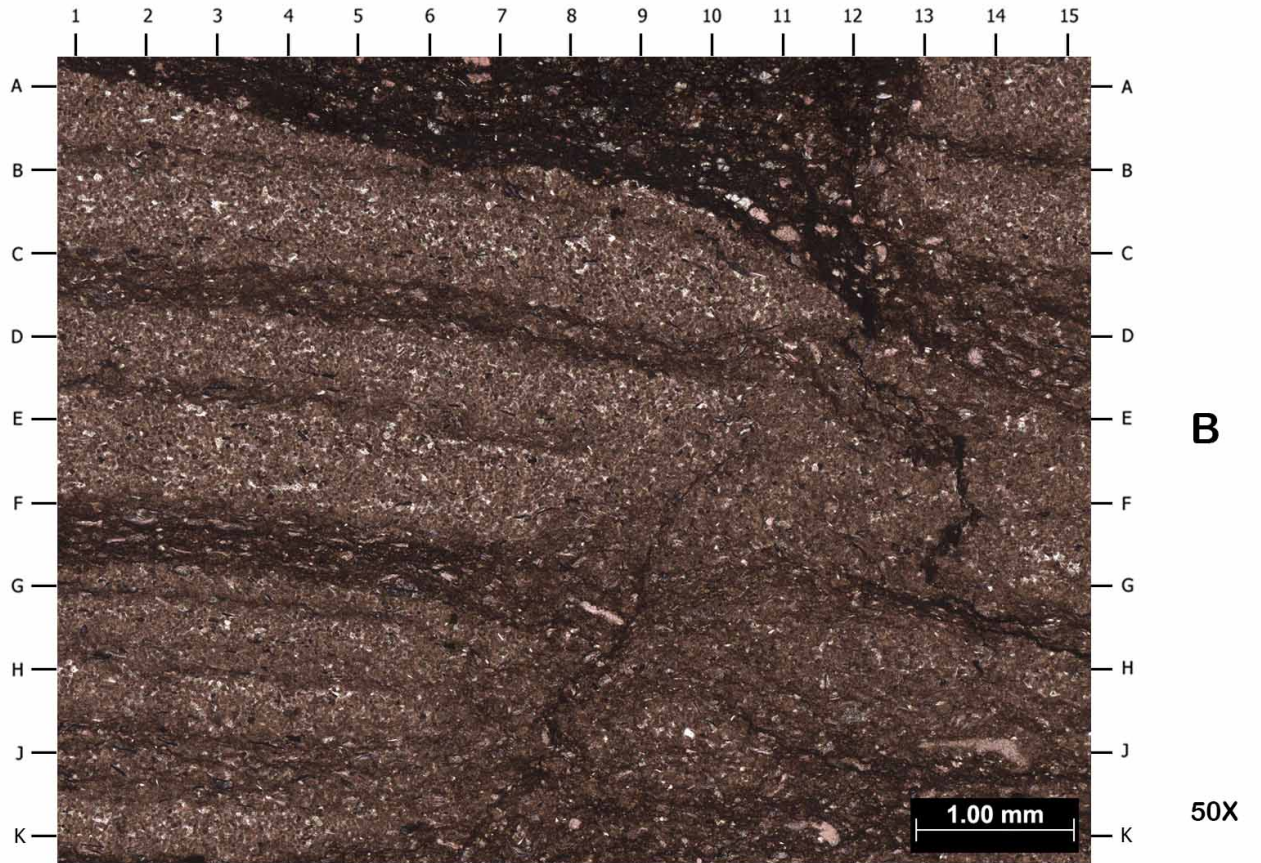
- B) This photo documents the area top-right of center in Photo A. Interlaminated layers of peloidal grainstone (BC1-CD10, D1-E9.5, EF1-F7.5, GH1-6) and clay/organic-rich laminations (darker; C1-DE10, FG1-7), visible on the left side of the image, are disturbed due to burrowing at GH7 to CK14. The edge of a thick carbonaceous/clay-rich lamination is visible at A2-AC12. Bitumen occurs concentrated along irregular microfractures within the burrowed zone (DE12-G13, GH8.5-J8, GH12-15).

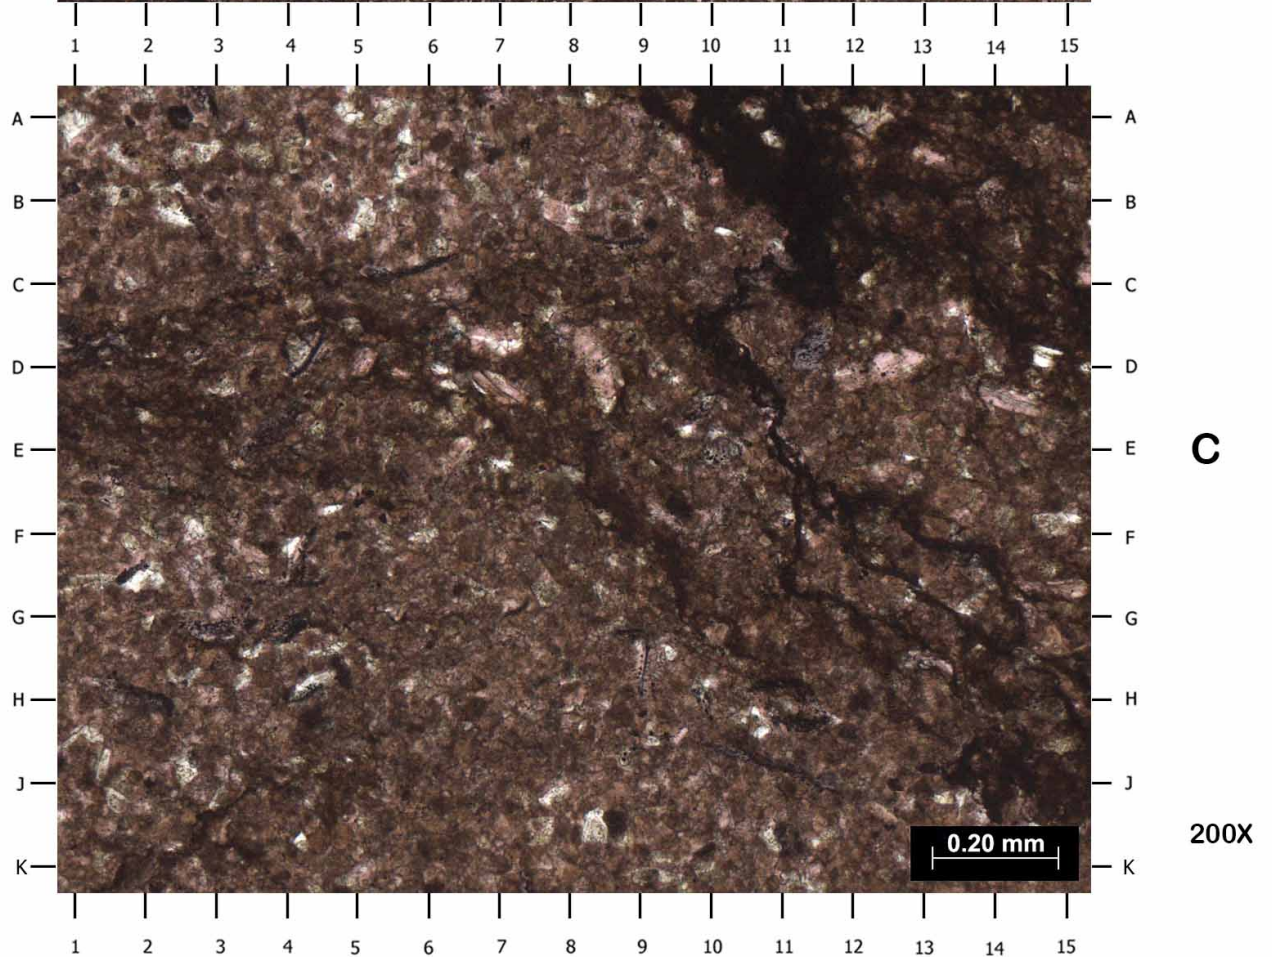
- C) This photomicrograph provides a high magnification view of the area centered near E11.5 in Photo B and focuses on the edge of the burrowed area. Preserved portions of the peloidal grainstone layers contain medium silt-sized peloids cemented by microsparry calcite (AC1-6). The matrix in the disturbed areas contains partially recrystallized micrite mixed with low amounts of clay and organic material. Bitumen concentrated along possible irregular microfractures occur at B11 to G11-14 (black). Visible grains/allochems include peloids (B4.3, HJ6.6, A2), quartz/feldspar (BC5, JK8.3, A1, FG4), muscovite (CD14.7), and undifferentiated calcareous fossil fragments (DE14.2, D12.5, DE8.2, DE7). Minor dolomite replaces unstable particles (D4, CD11.4, E10).

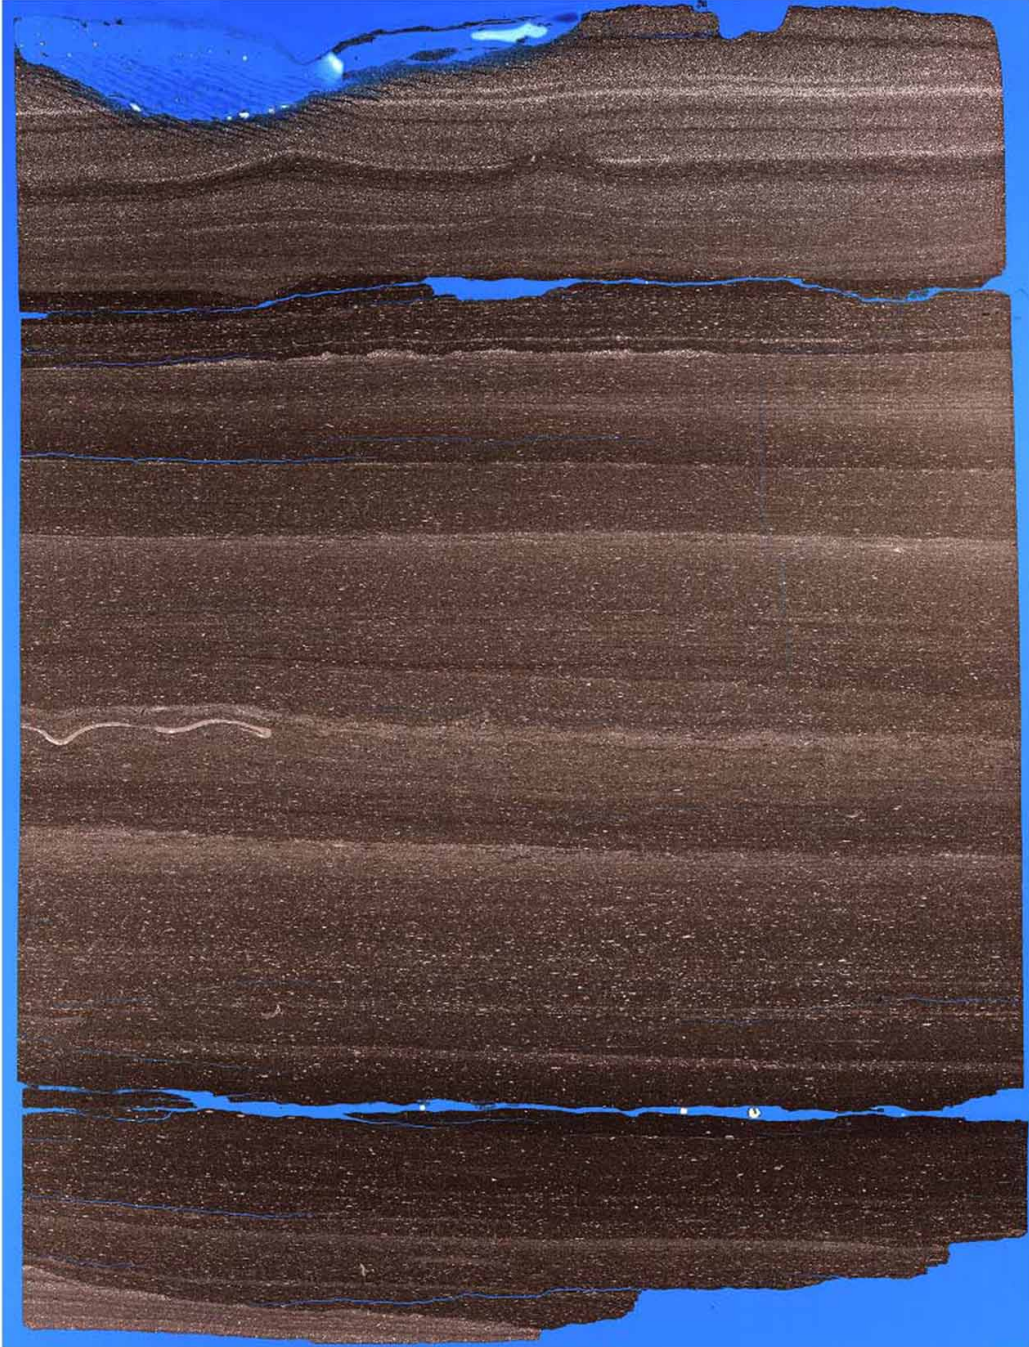
A

This static macro photo was captured from the high resolution thin section mosaic image and documents the entire thin section slide.

Lithology: Argillaceous limestone

Texture: Laminated wackestone to mudstone

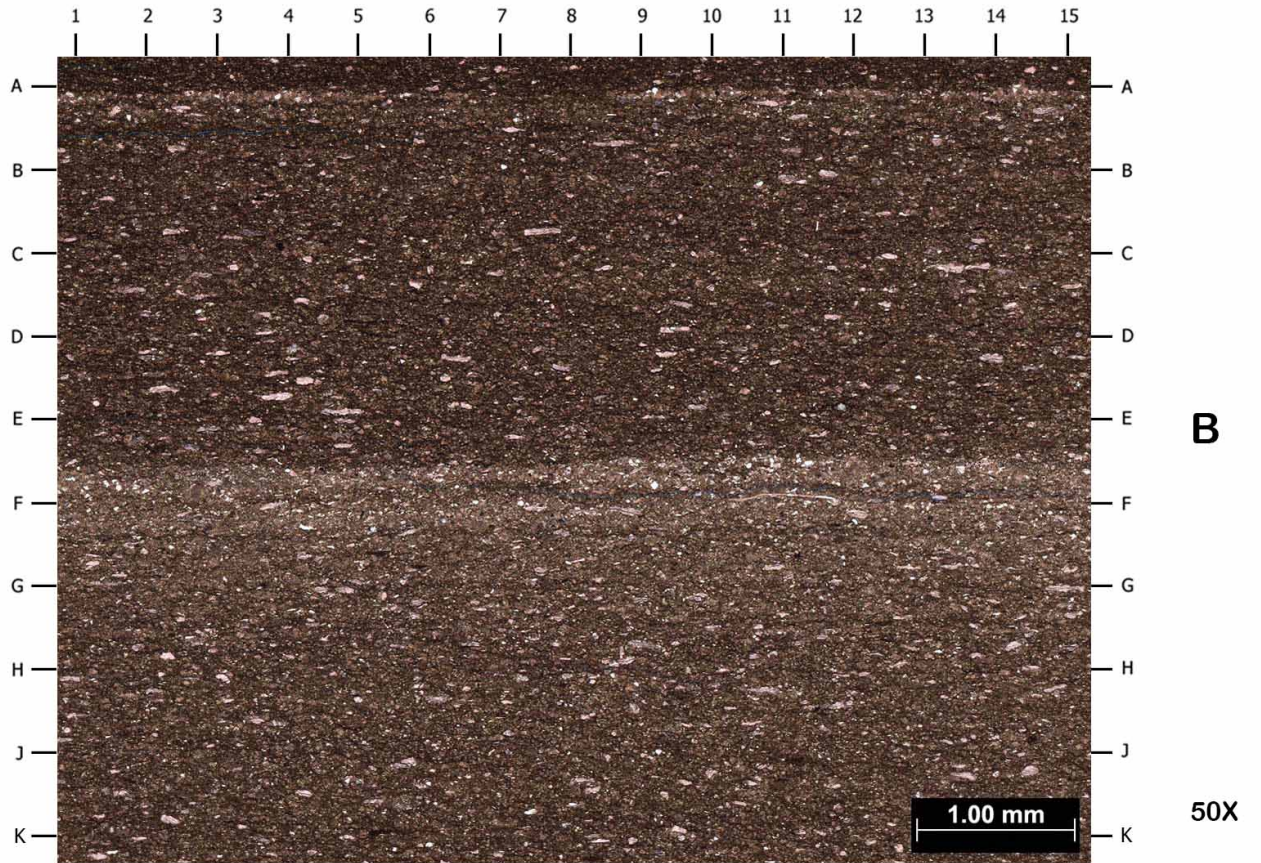
- B) This argillaceous limestone exhibits a laminated wackestone to lime mudstone texture. Individual layers vary in clay and organic content with darker bands likely containing slightly higher concentrations of clay and/or organic material (AE1-15).
- C) This photomicrograph provides a high magnification view of the area centered near AB12 in Photo B. Grains/allochems visible in this view include undifferentiated calcareous fossil fragments (AB2, A6, CD1.5, DE3, GH2.7, G5, EF11), silt-sized grains of quartz/feldspar (GH1, CD4, C4.5, E11, HJ10.6), muscovite mica (JK4.3, FG3.7), and altered organic plant/algal fragments (black; C13.5, DE10, EF13, H5.9). The matrix consists of abundant partially recrystallized micrite intermixed with common detrital clay and low amounts bituminous organic material.

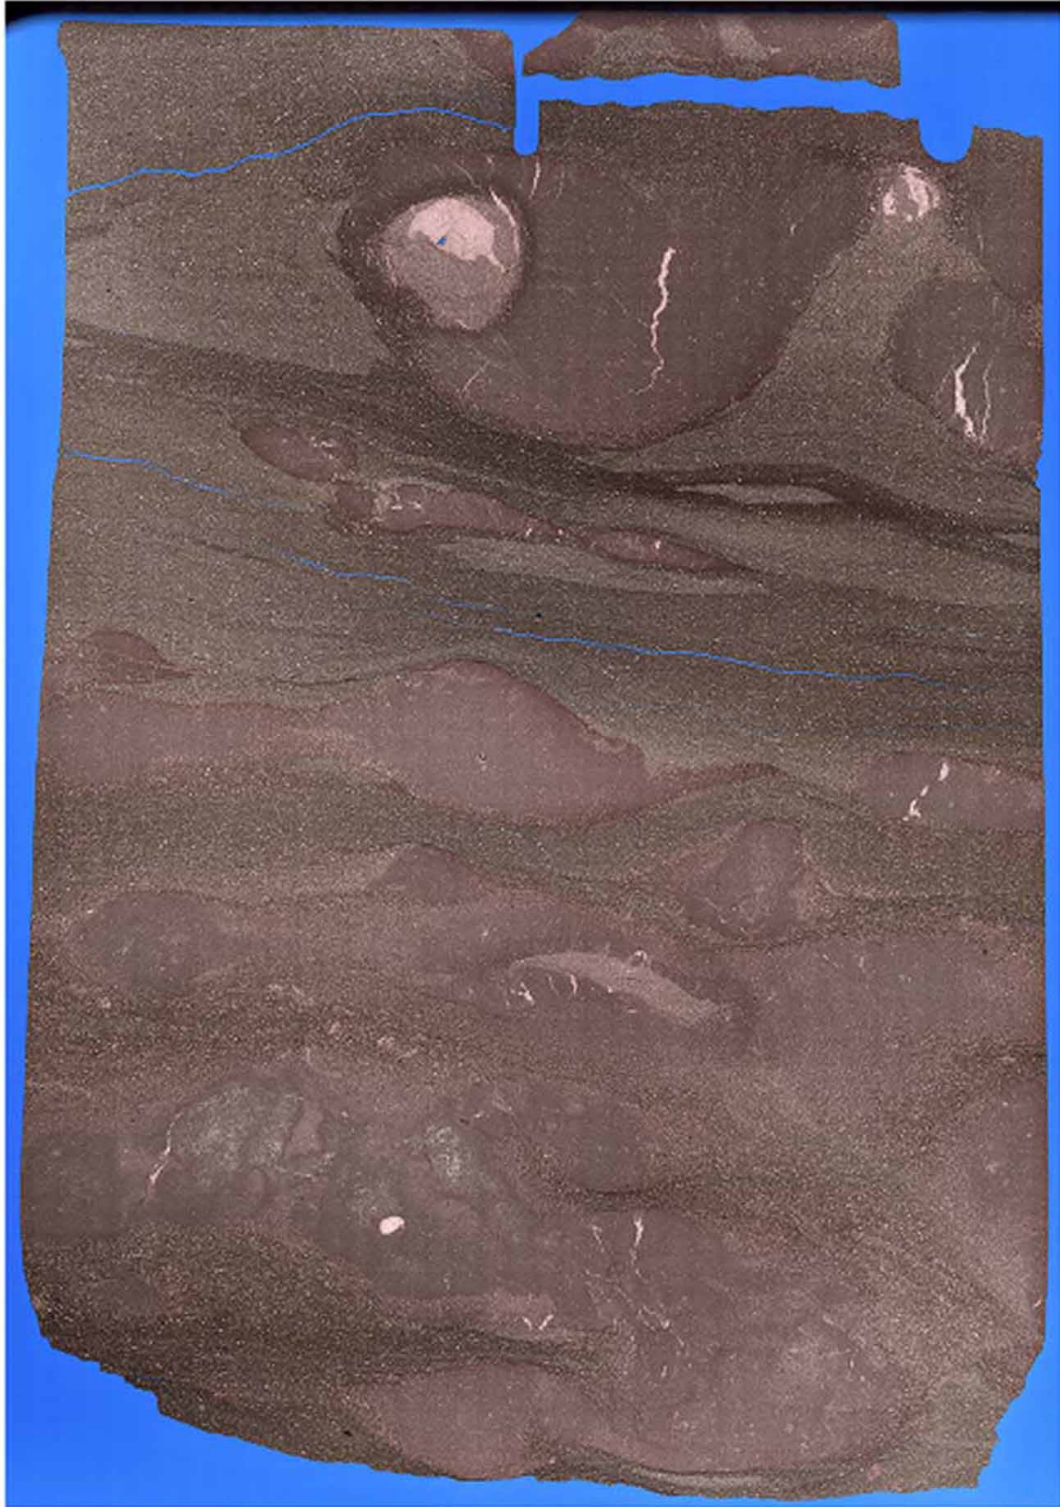
A

This static macro photo was captured from the high resolution thin section mosaic image and documents the entire thin section slide.

Lithology: Calcareous, dolomitic mudstone with interbedded limestone

Texture: Burrowed/bioturbated; laminated to interbedded; mixing soft sediments; calcareous/dolomitic mudstone interlayered with disturbed partially recrystallized lime mudstone layers and possible oversized limestone intraclasts; layers have been cross-cut and/or disturbed by extensive burrowing; localized calcite-cemented microfractures

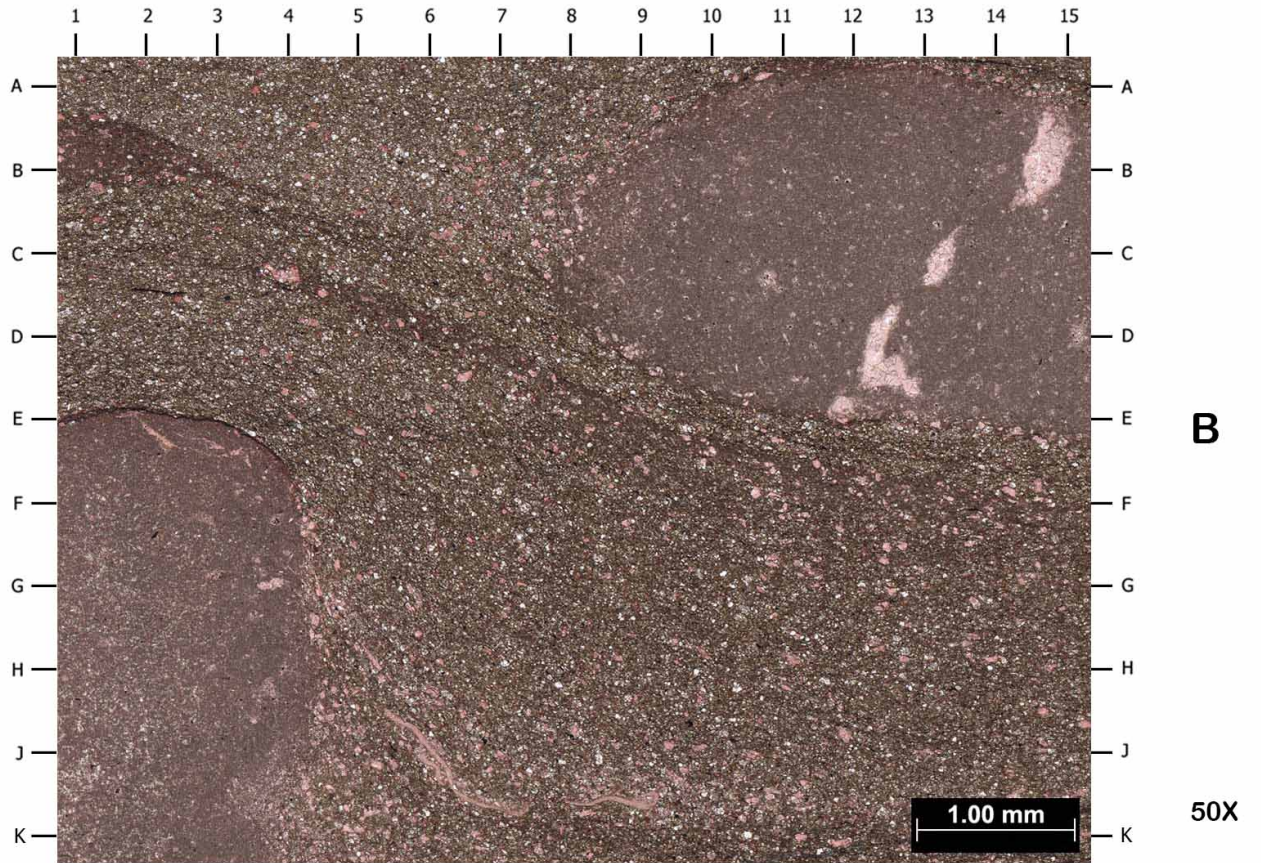
- B) This photo documents calcareous, dolomitic mudstone (AE1-8, FK5-15) with chaotic patches of partially recrystallized micritic limestone (C8.5-AE15, EK1-4). A discontinuous, calcite-cemented fracture occurs at B14.7 to DE12. Probable trilobite fossil material is visible at J6 and JK9.
- C) This photomicrograph provides a high magnification view of the area centered near DE10 in Photo B and shows a contact between calcareous/dolomitic mudstone (EK1-JK15) and limestone areas (AD1-AJ15). Grains/allochems visible in this view include undifferentiated, recrystallized calcareous fossil fragments (E13.3, GH11, BC4, AB1, B12.4, JK7.9), and silt-sized quartz/feldspar grains (GH4.9, JK11.8). In the mudstone portion, common to abundant dolomite occurs as replacement of matrix material and other unstable particles (GH6, J12.2, JK14.6).

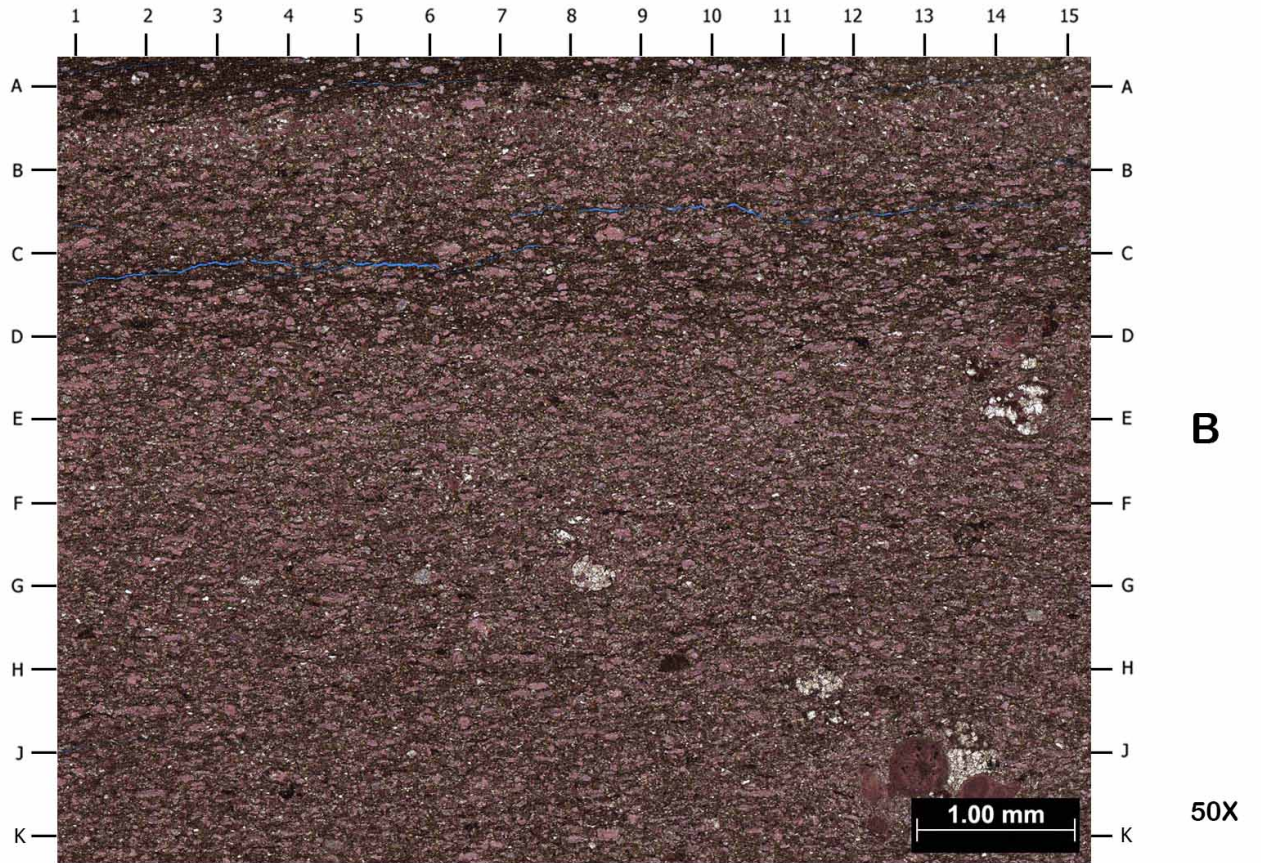
- B) This image was taken from the top part of the bottom half of Photo A, within a region that is predominantly argillaceous limestone (DK1-15). Clay-rich laminations occur at CD1-15 and A1-15. Probable agglutinated foraminifera occur at G8, H11.5, and E14.3; and an undifferentiated calcareous fossil fragment occurs at J13. The blue epoxy-filled microfracture at CD1 to BC14 is likely artificially induced.
