**Cambrian No. 1 Project
McCormick
Wayne County, West Virginia
Conventional Core Samples**

Weatherford File No.: HH-77641

**THIN SECTION MACRO PHOTO
SAMPLE DEPTH: 12134.00 FEET
SAMPLE NUMBER: 1 CK-McCormick**

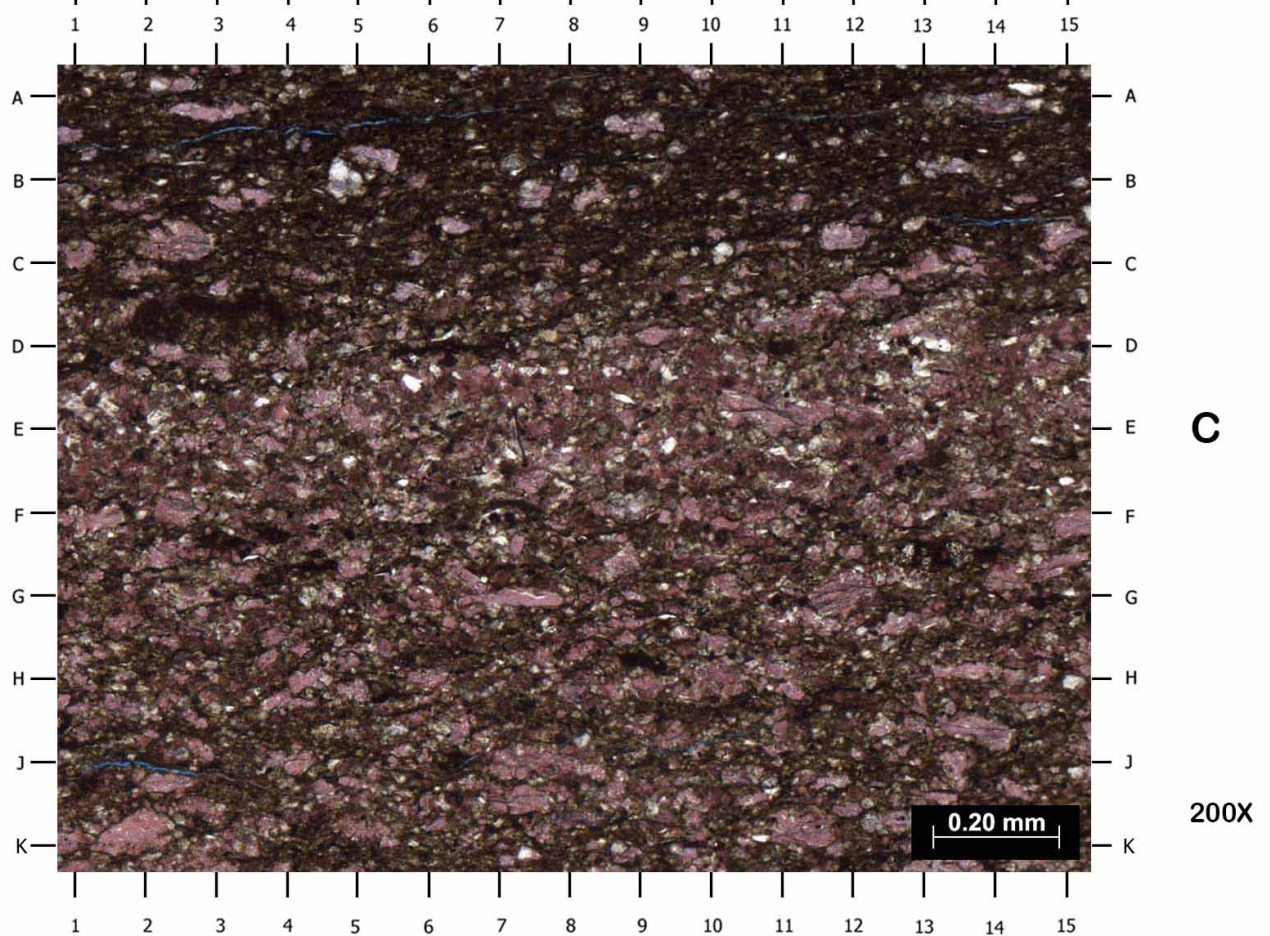
- C) This photomicrograph provides a high magnification view of the area centered near B3 in Photo B. Visible grains/allochems include undifferentiated calcareous fossil fragments (BC2.5, AB9, BC12, K2, HJ13.5), silt-sized quartz/feldspar grains (DE5.5, D13, EF14.9), altered organic plant/algal fragments (FG13-14, GH9, FG4.7, DE6), and muscovite mica (AB2.6). Darker areas of matrix likely contain low amounts of bituminous organic material intermixed within the calcareous/clay-rich matrix (AC1-15).

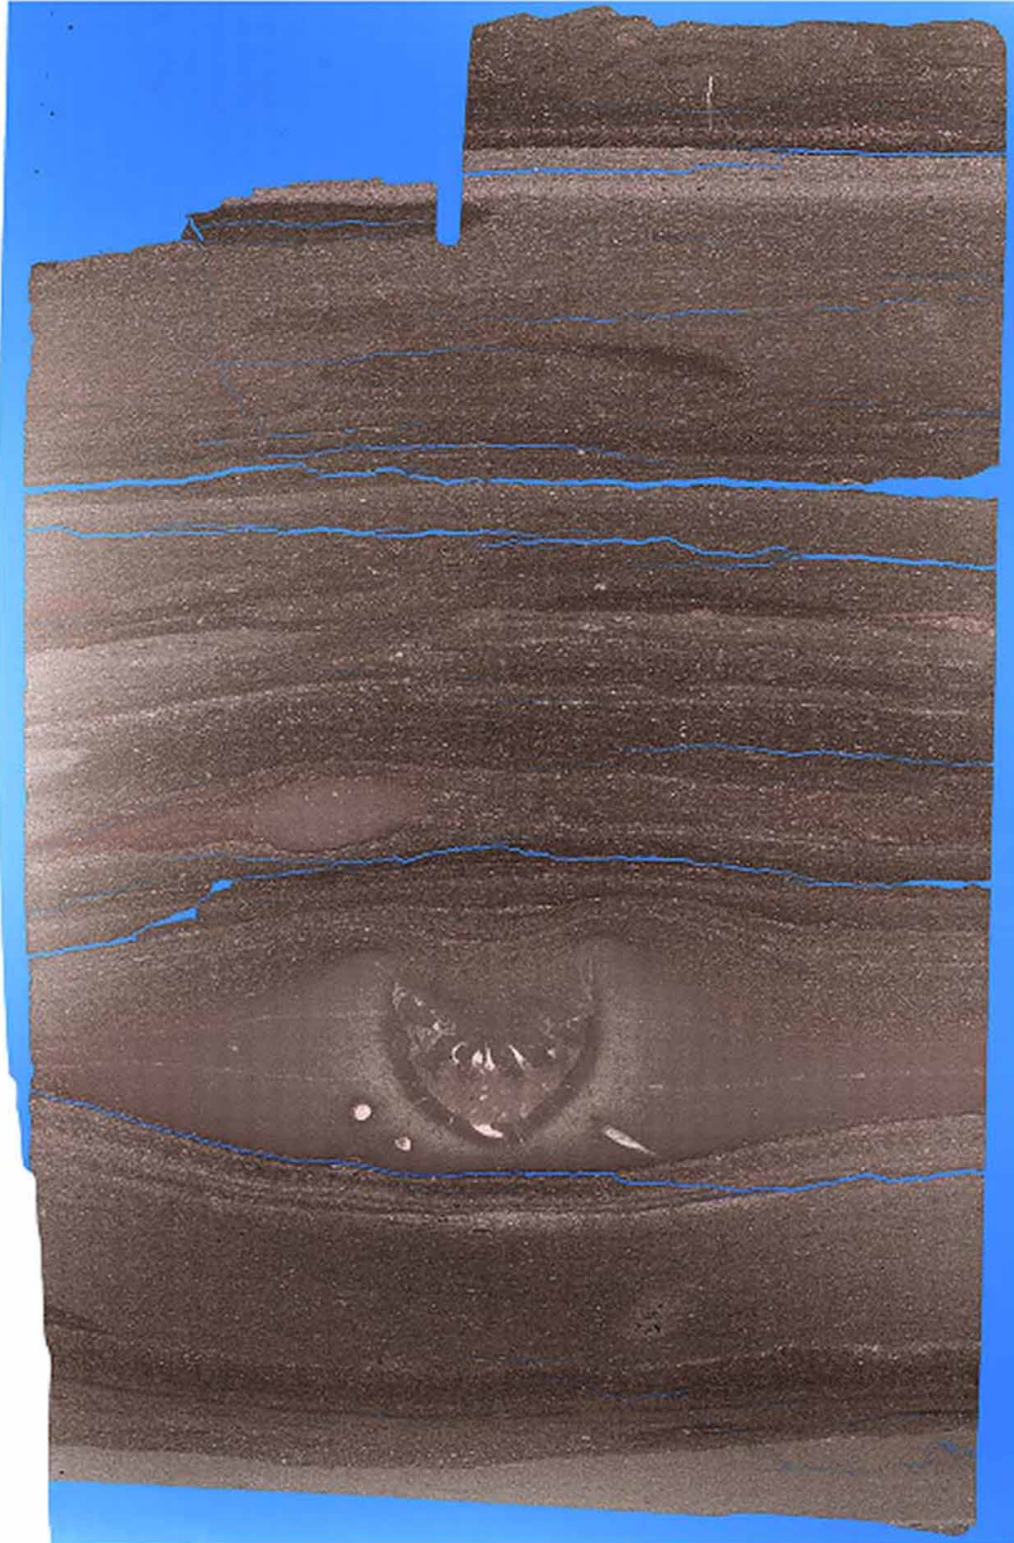
A

This static macro photo was captured from the high resolution thin section mosaic image and documents the entire thin section slide.

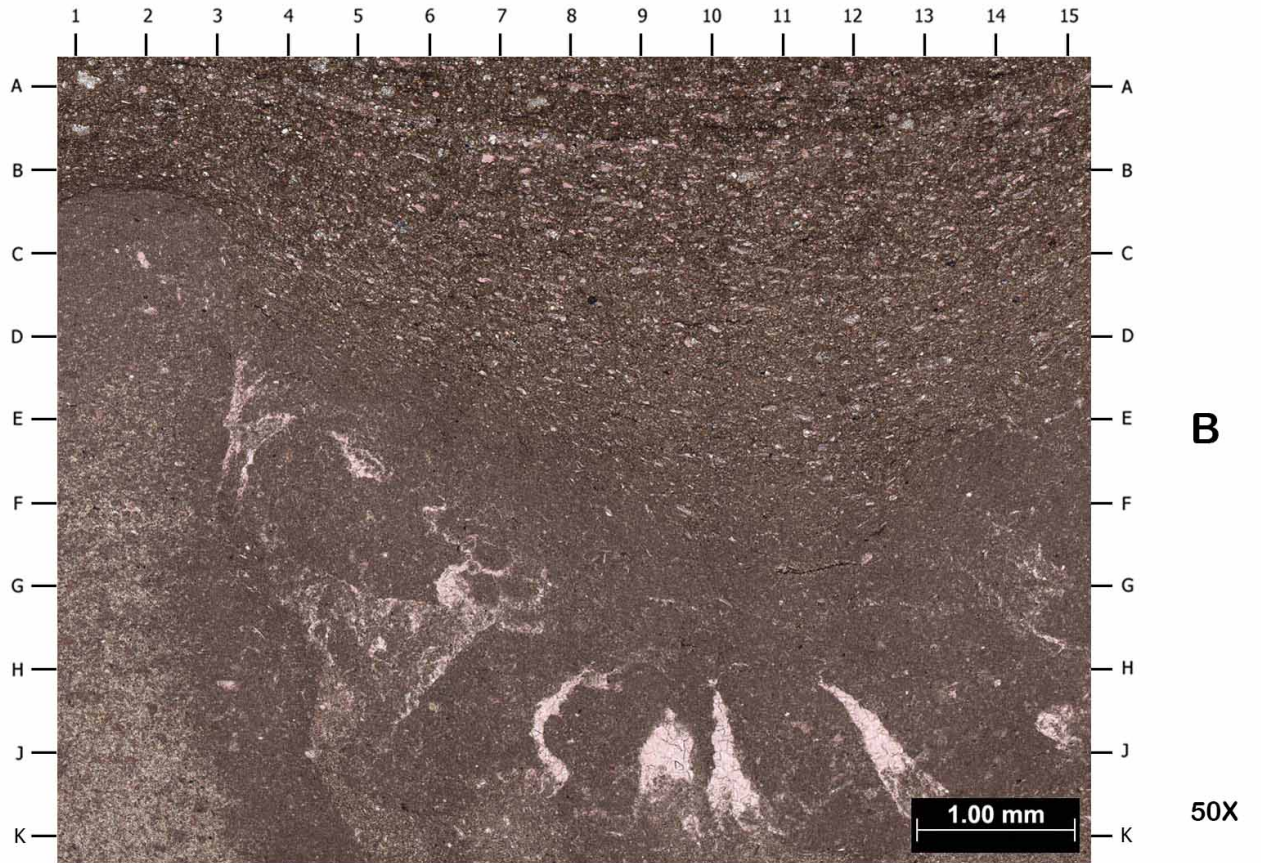
- B) The top-left portion of a possible fucoid algal fragment (EK3-15) is documented in this photomicrograph. This possible algal fragment is featured prominently in the center of the lower half of Photo A within a thickened layer of micritic lime mud (possible algal mat). This potential algal fragment, with a micritic wall (E3 to K4), exhibits the appearance of an open bowl with marine sediment deposited inside; localized calcite-filled microfractures (E3, GH6, J7.7, J9.5, J10.4, HJ12.3) associated with probable soft-sediment collapse are featured inside the "bowl". Dolomitization of the micritic matrix forms a halo around the outside of the bowl-shaped algal structure (F1-2 to K1-3).

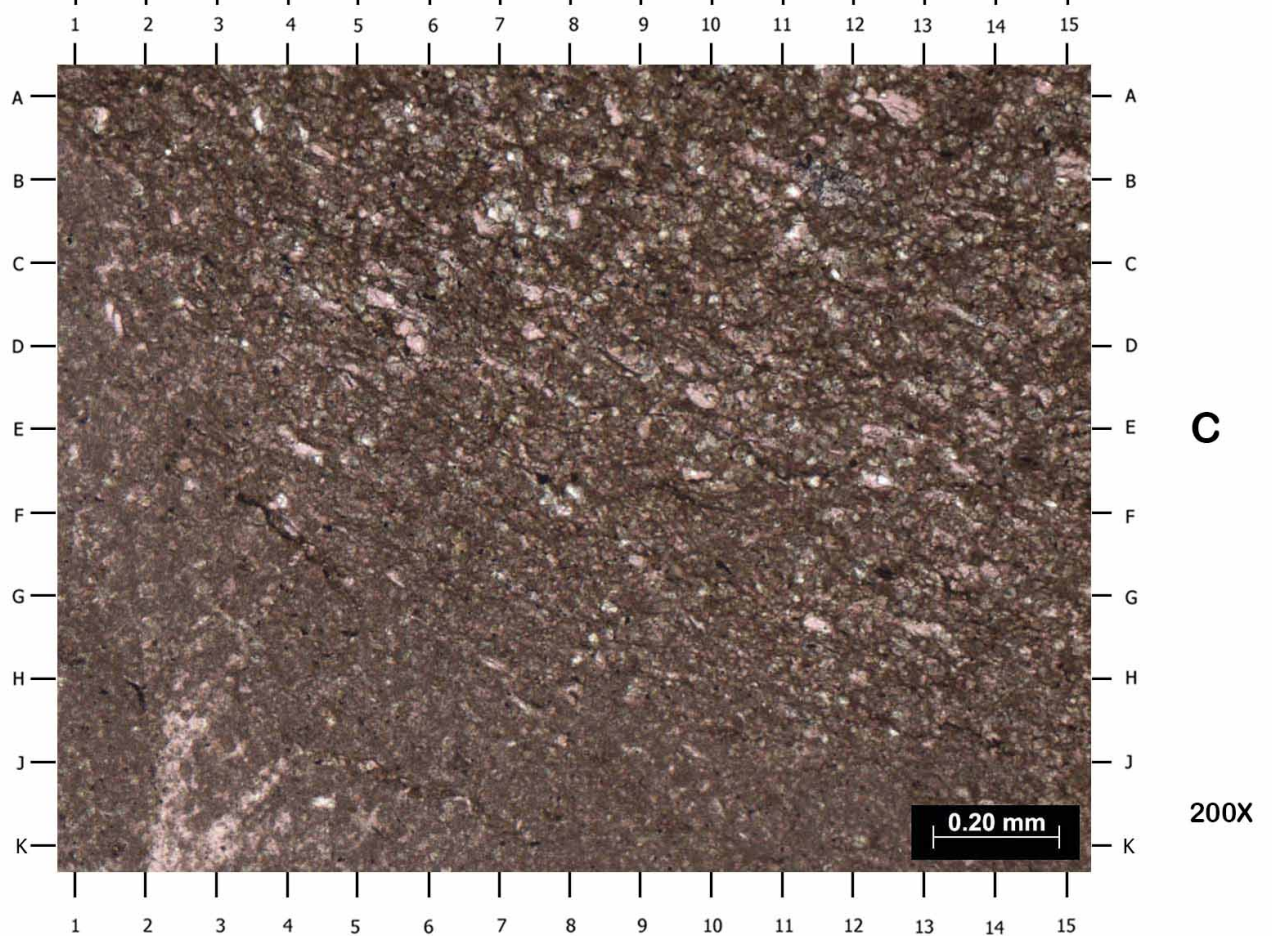
- C) This photomicrograph provides a high magnification view of the area centered near C5 in Photo B. The matrix material represented from AB5 to AD15 best represents what is dominant throughout most of this slightly silty, slightly dolomitic, argillaceous limestone to slightly silty, calcareous, dolomitic mudstone. Partially dolomitized and recrystallized micrite is intermixed with detrital clay and low amounts of bituminous organic material. Common to abundant undifferentiated calcareous fossil fragments occur scattered throughout the sample (AB12.5, DE9.9, D5.5).

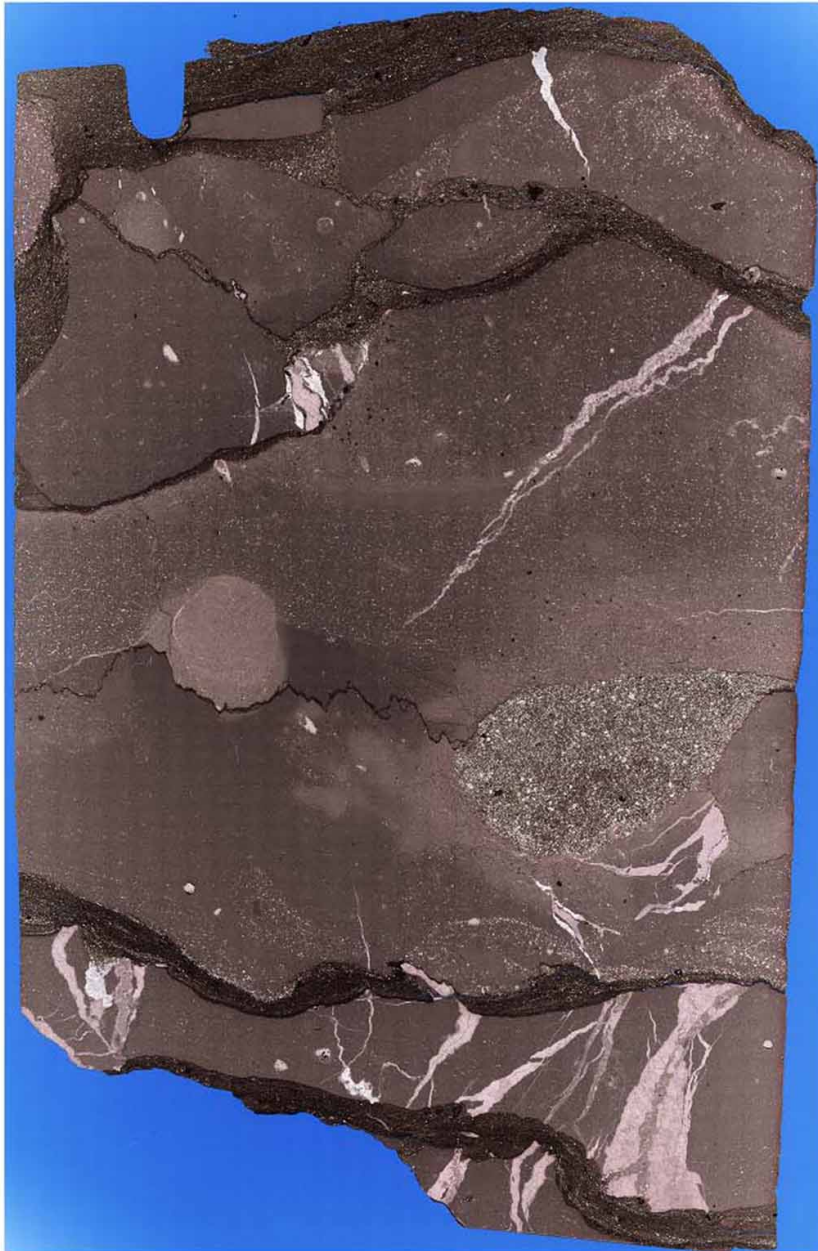
A

This static macro photo was captured from the high resolution thin section mosaic image and documents the entire thin section slide.

Lithology: Micritic limestone (dominant); dolomitic mudstone (minor lithology at top of section and within fractures/stylolites)

Texture: Highly fractured, bioturbated lime mudstone to wackestone (dominant) in contact with dolomitic mudstone (top of section); calcite-cemented fractures; organic/clay-rich stylolites; large fractures filled with dolomitic mudstone

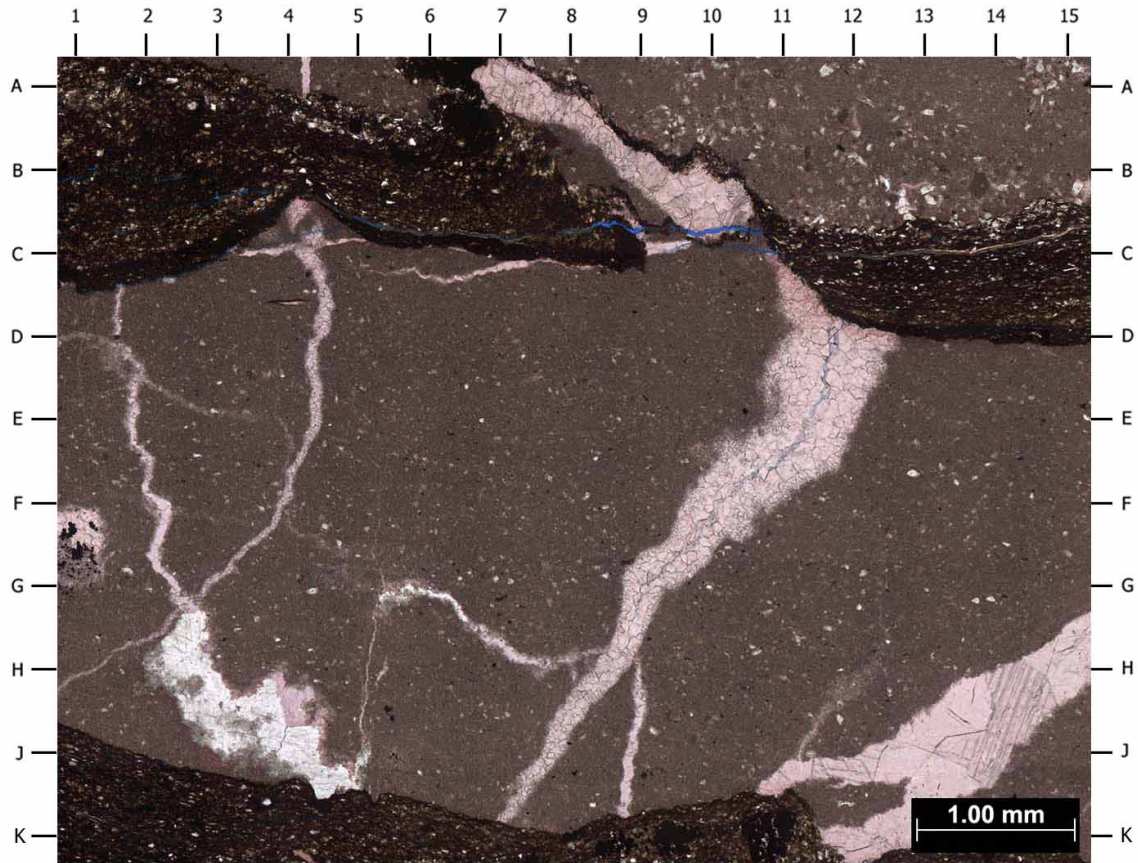
- B) The dominant bioturbated micritic lime mudstone to wackestone (DH1-DK15, A4-AB15) contains numerous calcite-cemented fractures (stained red; A7-BC10, D11.5-JK7, K12-H15). Dolomite cement occludes a fracture at H2.5-JK4.5. Dolomitic mudstone occurs concentrated within stylolites and fractures (AC1-CD15, JK1-K11.5).
- C) This photomicrograph provides a high magnification view of the area centered near J10 in Photo B. Minor silt-sized grains of quartz and feldspar occur scattered throughout the limestone and mudstone lithologies (most white; AB15, CD6.5, HJ3.7, K6.5). Pyrite (black) replaces unstable particles at JK2, JK5.5, and HK10-12. Small dolomite crystals are prevalent throughout the clay-rich matrix areas (JK8, H8.4).

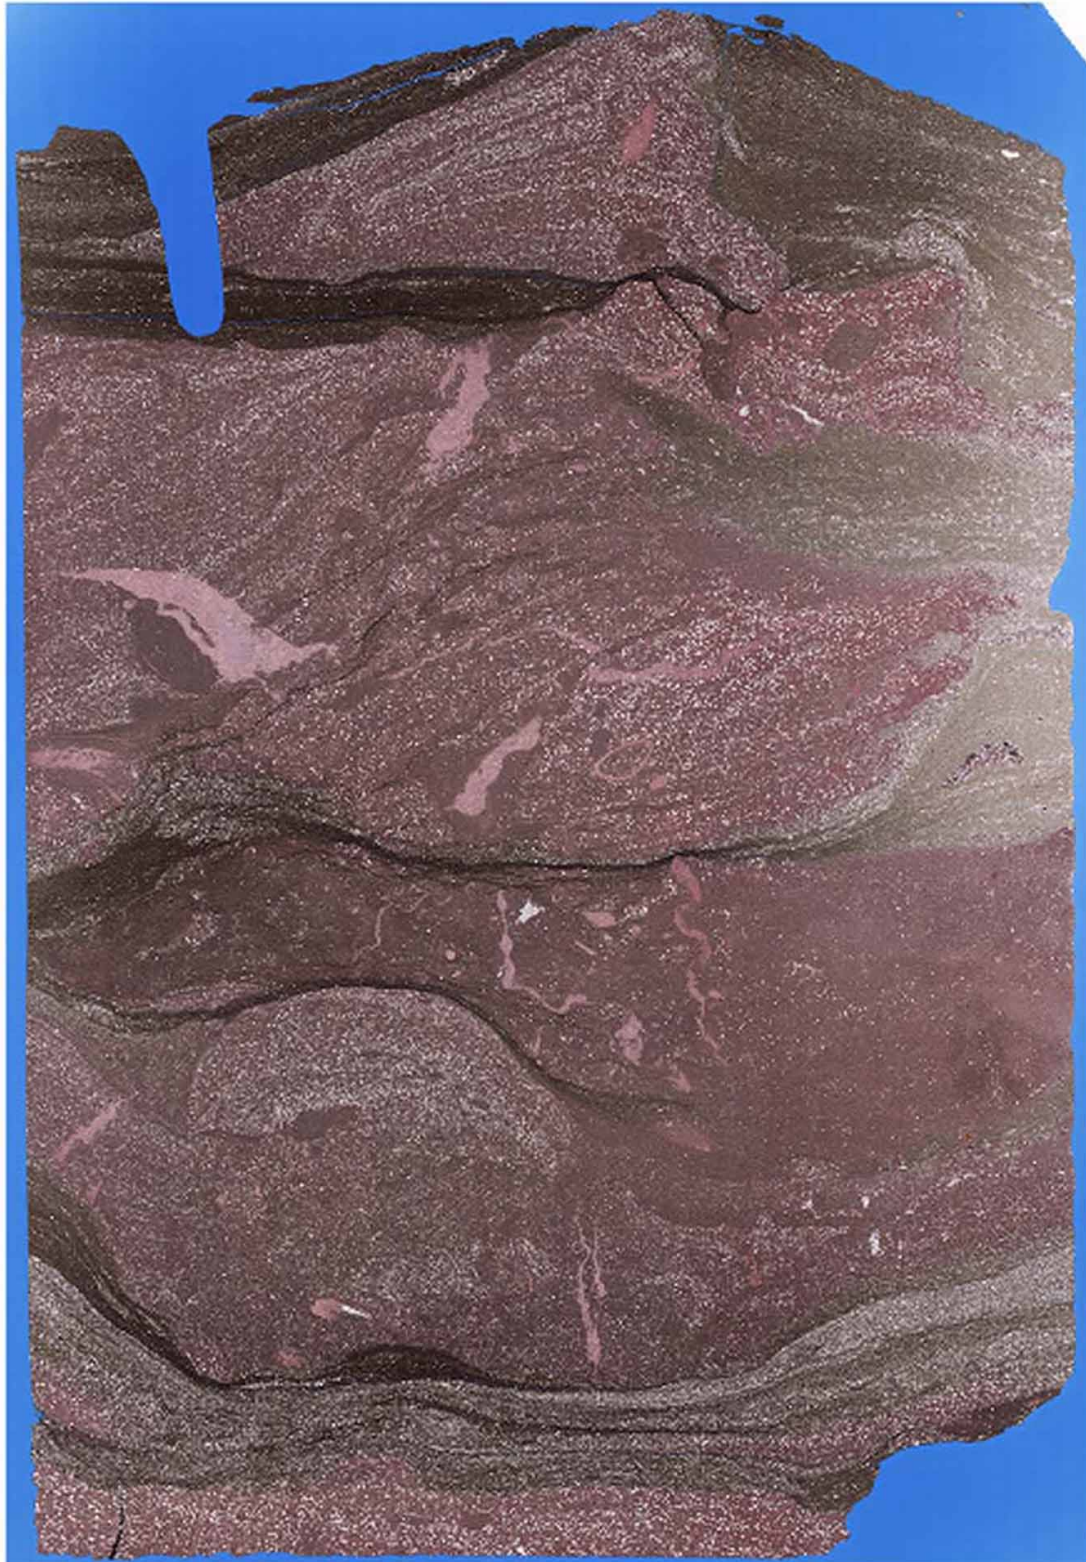
A

This static macro photo was captured from the high resolution thin section mosaic image and documents the entire thin section slide.

Texture: Burrowed; soft sediment deformation; possible cross-laminations and flaser bedding; partially recrystallized, silty wackestone with patchy silty grainstone/packstone thinly interlaminated/interbedded with slightly calcareous, silty, dolomitic mudstone; mixing marine and terrigenous soft sediments; localized, irregular, calcite-cemented fractures limited to limestone layers, possibly caused by deformation of limestone fabric after initial partial lithification; rare organic-rich microstylolites

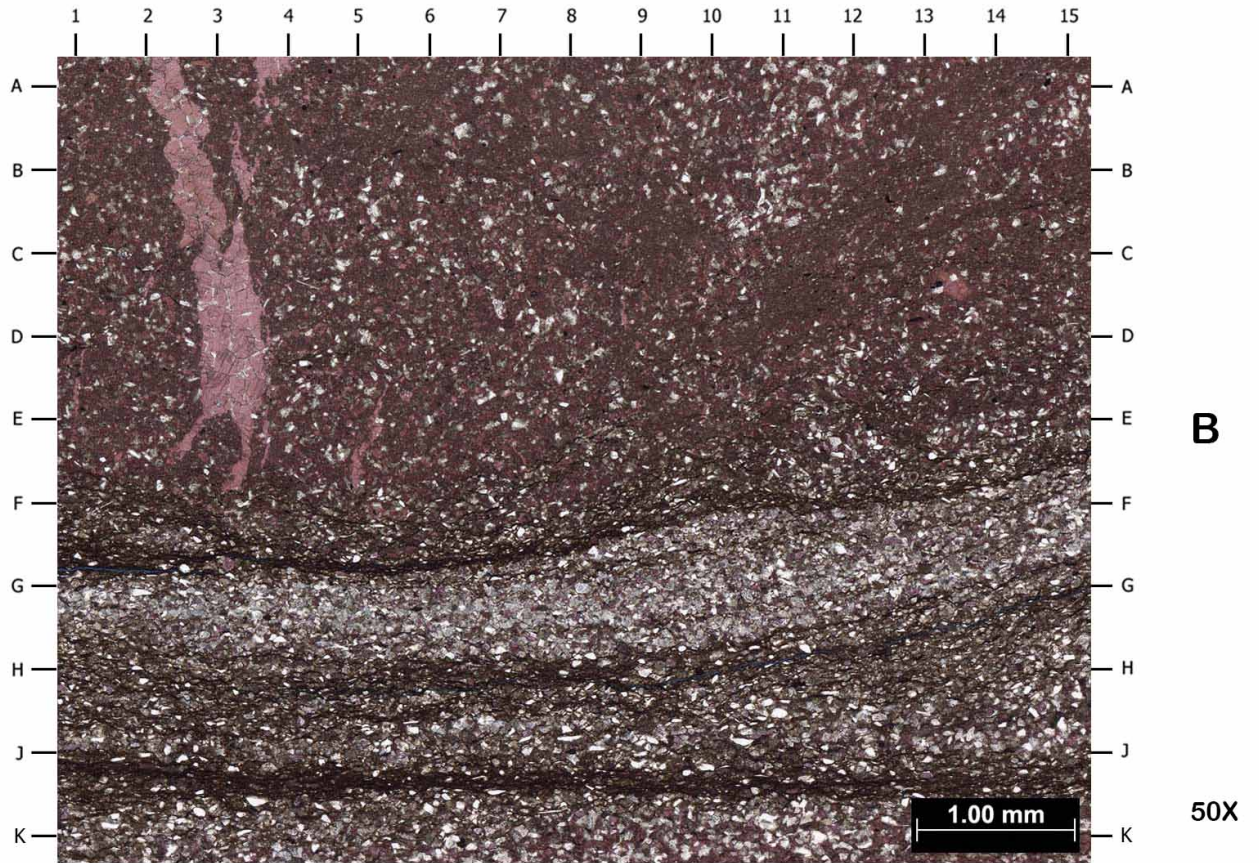
- B) This photo documents an area taken from the near the bottom of the section in the macro Photo A. The upper portion of this view represents slightly dolomitic, silty limestone with a burrowed wackestone to packstone texture. The lower portion of the photo documents a layer of slightly calcareous, silty, dolomitic mudstone. The calcite-cemented fractures, such as seen at A2 to EF3, are interpreted to be a result of deformation of the limestone sediment after initial partial lithification had taken place.

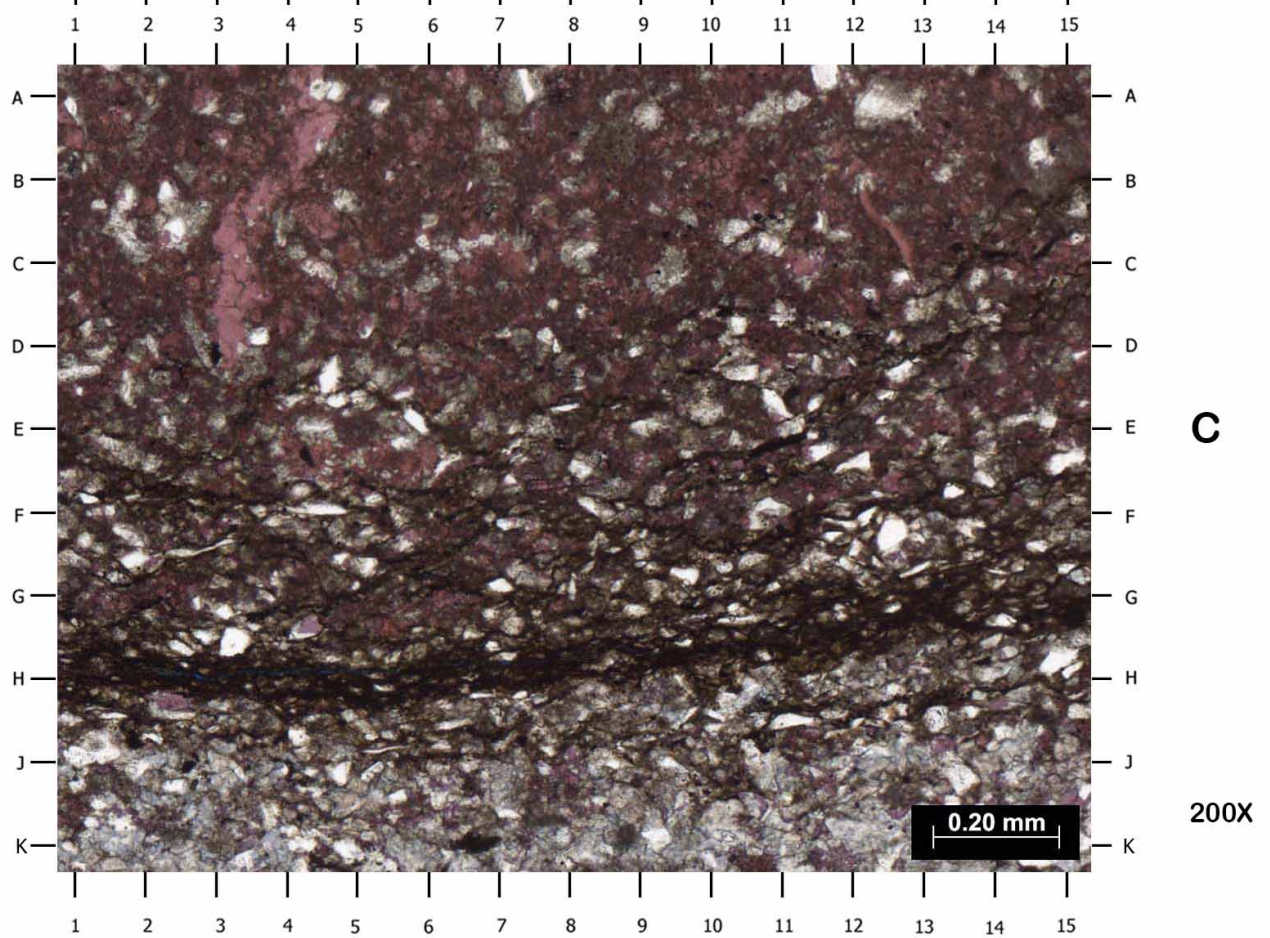
- C) This photomicrograph provides a high magnification view of the area centered near F6 in Photo B. Grains/allochems visible in this view include silt-sized grains of quartz (FG12.5, G7, BC2.3) and feldspar (DE10.2, J13.4, AB12.5), recrystallized calcareous fossil fragments (B10, C7, BC12.5), and muscovite mica (FG2.7, F4.3, FG13). A smaller calcite-cemented microfracture occurs at D3 to A4 (stained red). Organic material and detrital clay occur concentrated along a thin lamination at H1 to G15. The layer represented at JK1-15 contains higher concentrations of dolomite (K1.5, JK10, J14.2) replacing the matrix and unstable grains/allochems; this same layer is pictured at GH1-F15 in Photo B.

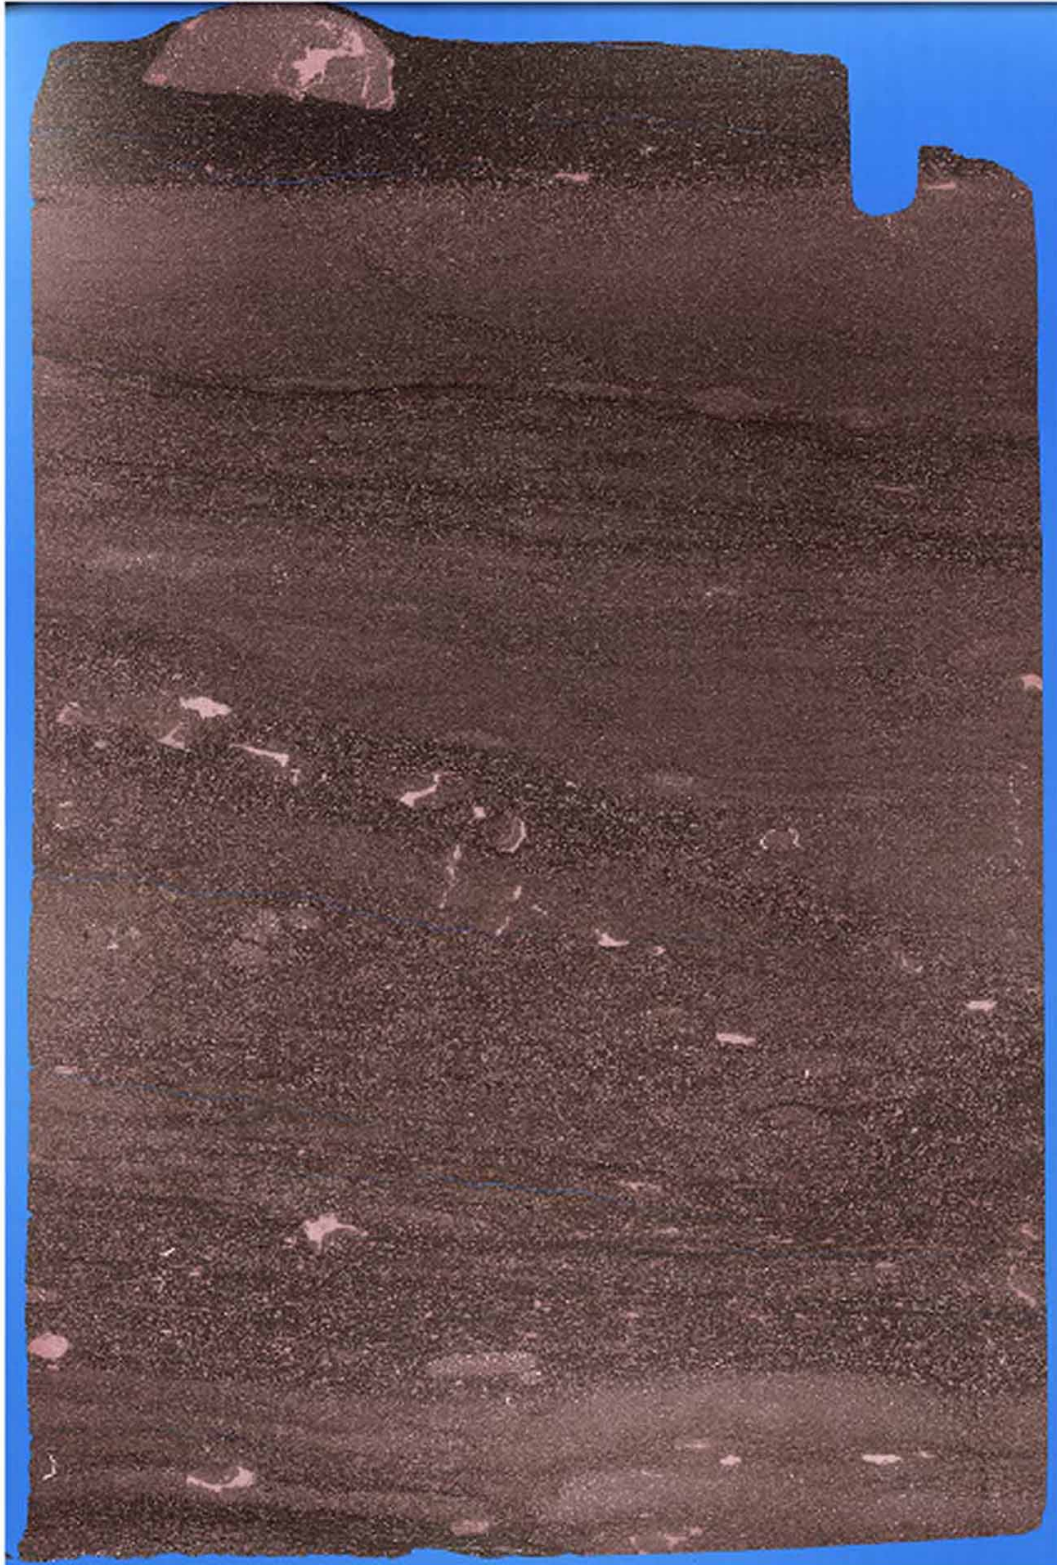
13697.50'
Plate 42

A

1X

- B) This slightly silty, very argillaceous limestone (marl) contains highly calcareous layers dominated by a combination of micritic matrix and interparticle microsparry calcite cement (EK1-15), and layers containing mixed partially recrystallized micrite and detrital clay (AD1-15). A probable trilobite fossil fragment that is partially replaced by quartz occurs at CD1.2-3.4. Other undifferentiated allochems completely recrystallized to sparry calcite occur at JK2 and JK12-14.

- C) This photomicrograph provides a high magnification view of the area centered near DE5.5 in Photo B. Grains/allochems pictured in this view include undifferentiated/recrystallized calcareous fossil fragments (stained red; CD1.5, AB5.4, EF6, A15, H4, J10.3, BC10.5, E8.5), quartz (C12, CD5.7, BC5, AB13.8), feldspar (HJ9.8, F7, HJ8.7), micritic peloids (HJ4, F12, HJ13), biotite (G14), organic fragments (C6). The more calcareous layer from GK1-FK15 contains patchy areas interparticle microspar calcite cement (HJ4.9, JK7.3) between silt-sized grains/allochems. Dolomite replacement occurs at HJ11.2, JK7.7, and FG14.4.

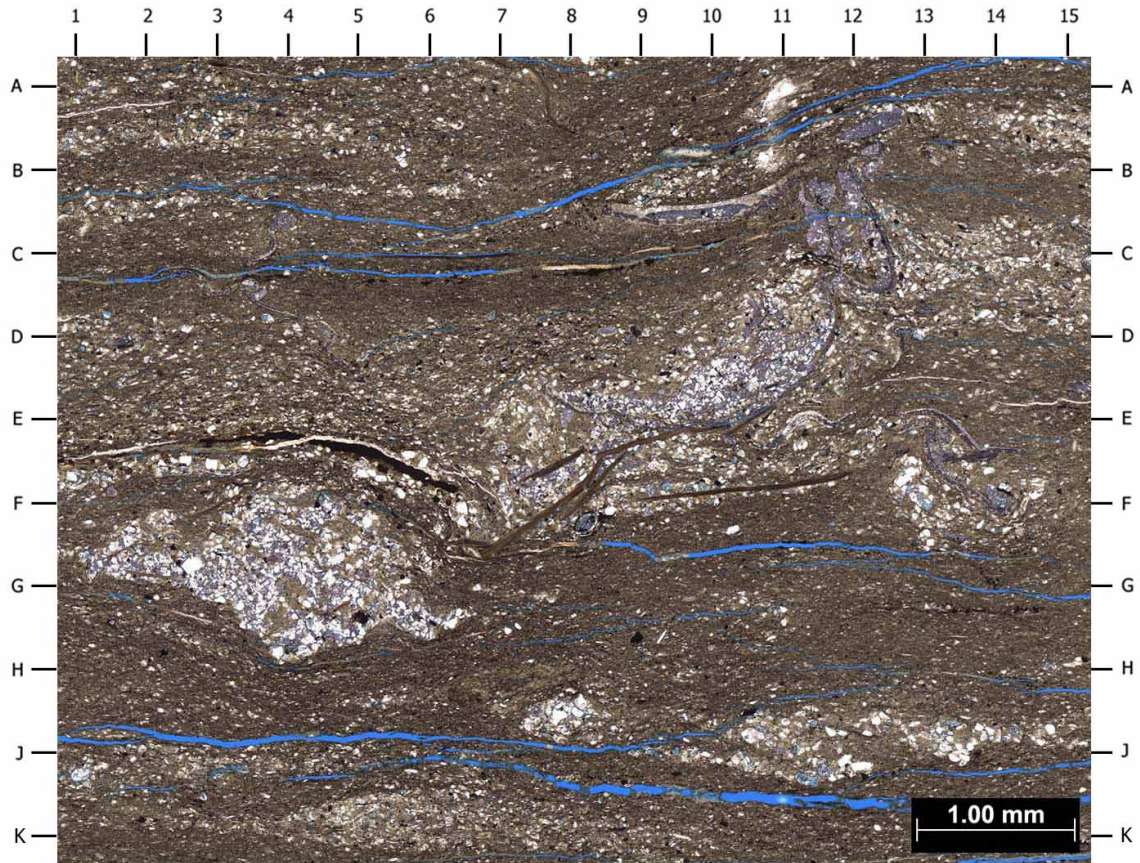
B

- B) This photo demonstrates well the burrowed and laminated texture of this silty mudstone. Common silt-filled burrow structures (FG2-6, HJ8) and disturbed silty laminations (DE1-CD15, JK4-9, J10-15, AB1-6) occur throughout the sample. Open horizontal fractures (blue epoxy; J1-9, JK4-12.5, BC3-A13, FG8-G15) are interpreted to be artificially induced despite gypsum cement (CD8, EF1-5) precipitating along many of them.

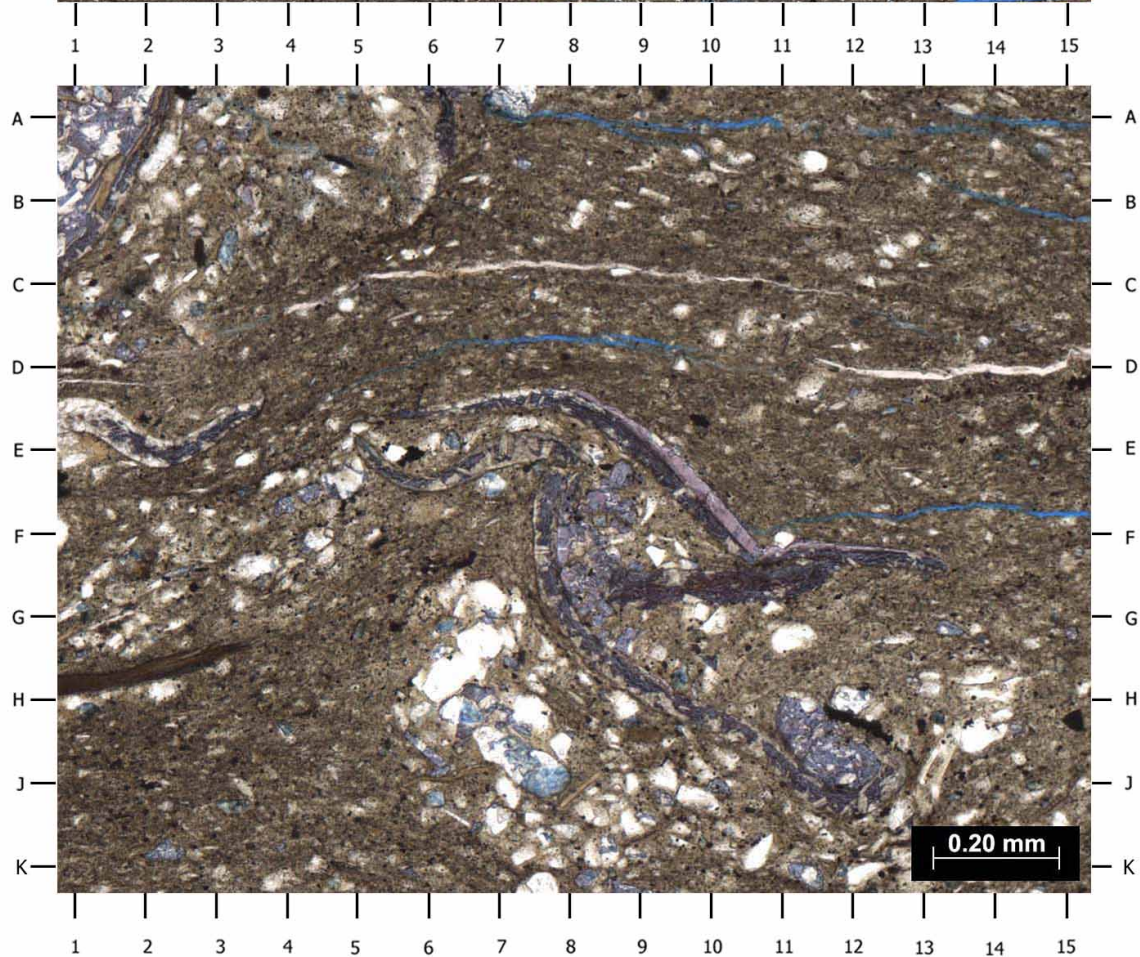
C

- C) This photomicrograph provides a high magnification view of the area centered near EF13 in Photo B. In this view, broken trilobite carapace fragments are replaced by ferroan calcite (stained purple; E9, FG10, F7.5, J12), dolomite (E7; not stained), and quartz (EF1-1.3). An elongate phosphatic fragment at H1 to GH3 may represent altered/replaced biotite. A splayed biotite fragment at AB1.5 occurs within a silt-filled burrow with ferroan calcite locally filling the intergranular spaces (AB1.2). Common quartz (GH6.5, AB11.5) and minor feldspar (EF4.8, H12) occur scattered throughout the sample and locally concentrated within burrows and along laminations. Artificially induced microfractures at C5-11 and D12-14.9 (white) are filled with gypsum cement; this gypsum cement likely reprecipitated within these open fractures relatively recently, after core extraction.

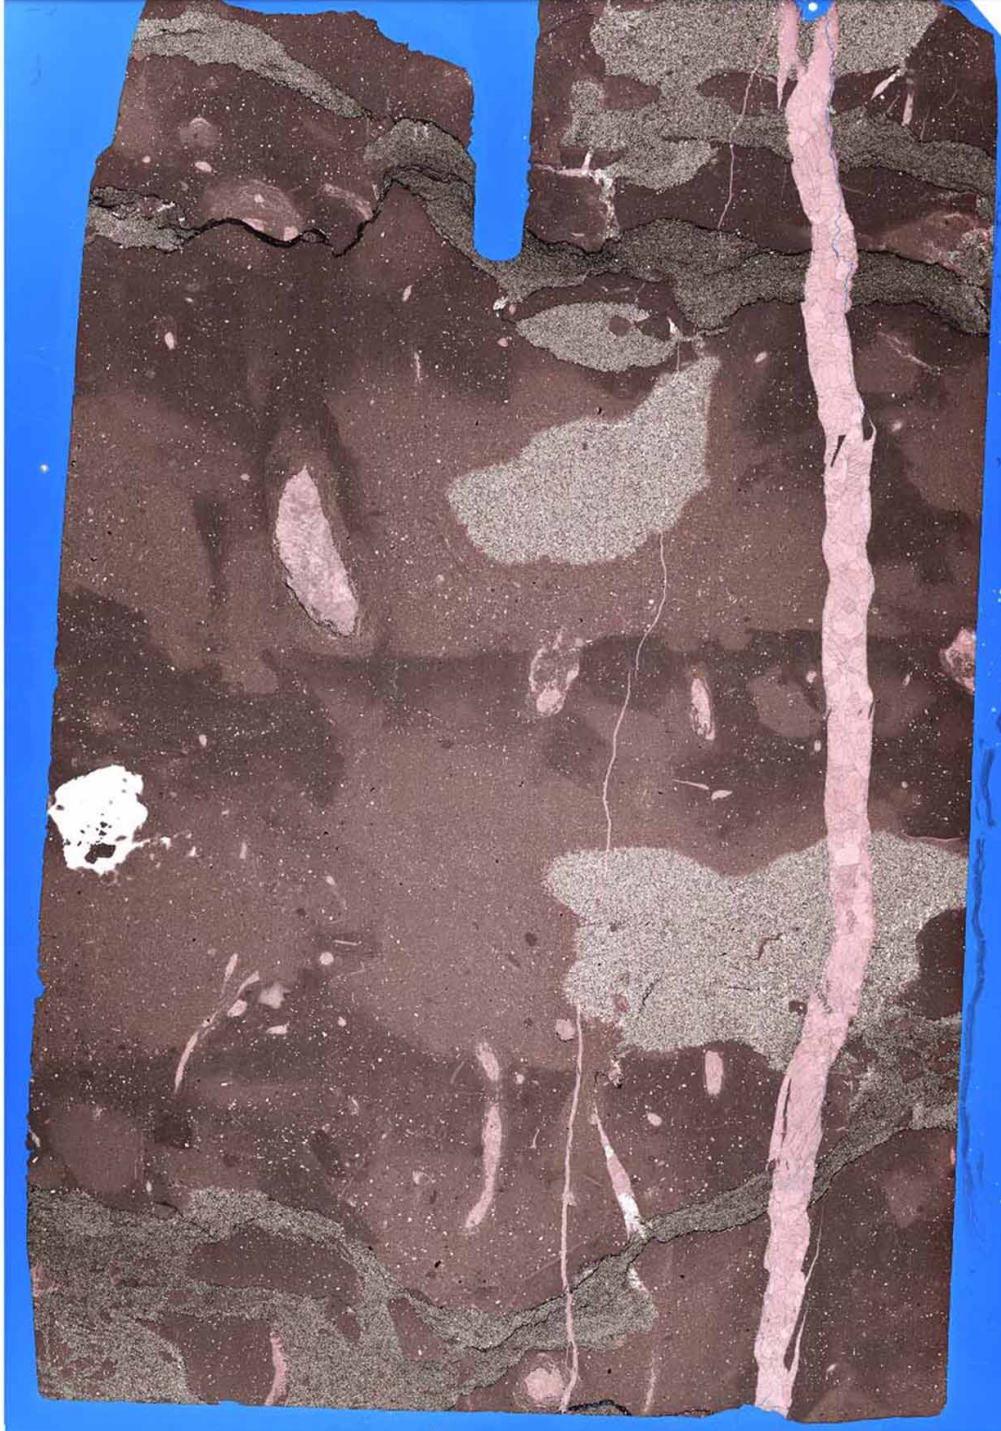
A

This static macro photo was captured from the high resolution thin section mosaic image and documents the entire thin section slide.

Texture: Burrowed; mottled; soft sediment deformation; minor dolomitic laminations and irregular dolomitized patches (occurring in association with stylolites and possible replaced burrow structures); vertical, calcite-cemented fractures and microfractures; stylolites; lime mudstone to wackestone with patchy matrix recrystallization (possibly associated with various stages of burrowing; difficult to discern the precise nature of the diagenetic overprint)

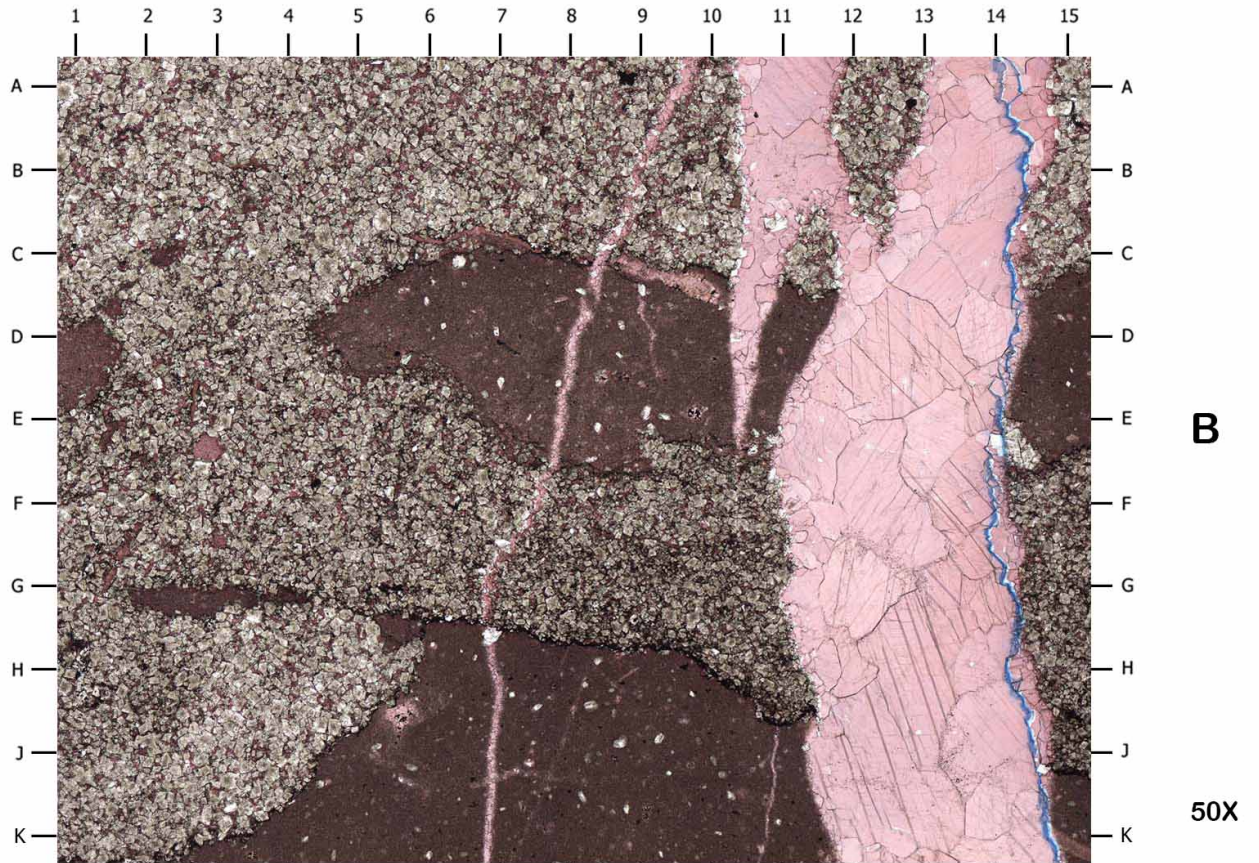
- B) This image was taken near the top-right corner within the macro photo A and focuses on an irregular-shaped patch of finely crystalline dolomite (AC1-8, F1-6, HJ1-4, AC15, G8-11, FJ15) replacing the dominant micritic calcite matrix (D5-8, DE9-10, DE15, JK4-6, JK7-11). Although the dolomite appears dominant in this localized area, this sample is predominantly lime mudstone to wackestone (see Photo A), with minor to common dolomitized patches (8% by weight, total dolomite/Fe-dolomite). A large fracture cemented by coarsely crystalline calcite spar (AK13.5) and smaller calcite-cemented microfractures (K7 to A9.6) cut vertically across this slightly dolomitic limestone. An open fracture, filled with blue-dyed epoxy (A14-K15), cuts through the calcite-cemented fracture, but was likely artificially induced during sample preparation or core acquisition.

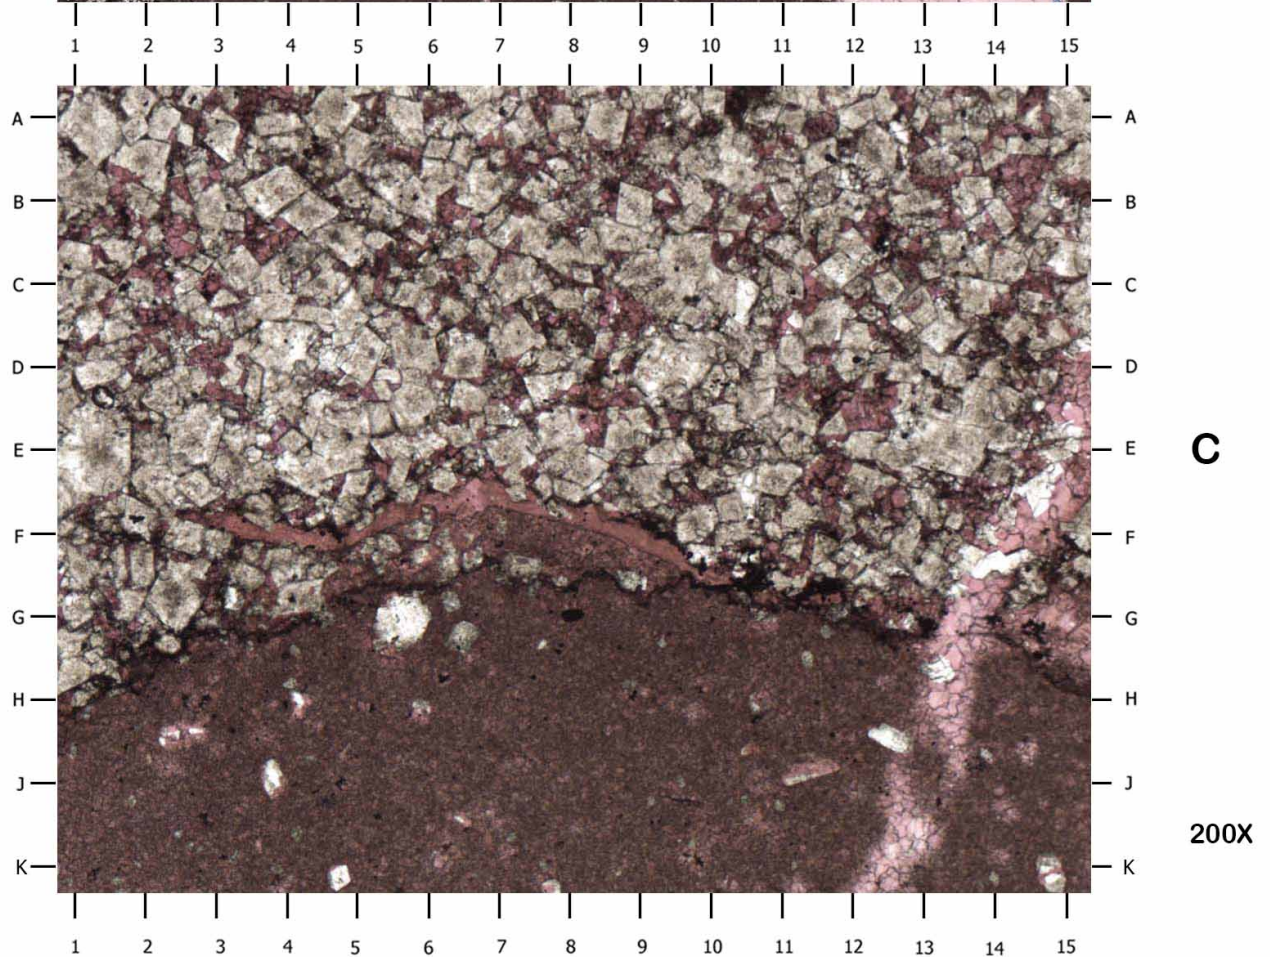
- C) This photomicrograph provides a high magnification view of the area centered near C7 in Photo B and documents a thin, organic-rich, microstylolitic contact (black; H1-GH13) separating the micritic matrix (stained red; HK1-15) from the dolomite-replaced matrix (AG1-15). A calcite-cemented fracture occurs from K12 to DE15. Grains/allochems visible in this view include feldspar grains (GH5.6, K4.7, J3.7, HJ12.4), partially pyritized organic fragments (black; G8, J4.8, GH6.2), and a probable trilobite fragment (F3-FG10).
